## Photographic Documentation

**Name of Facility:** Partners Produce, Payette

**Inspection Date:** Thursday, April 09, 2020

**Purpose of Inspection:** Complaint investigation

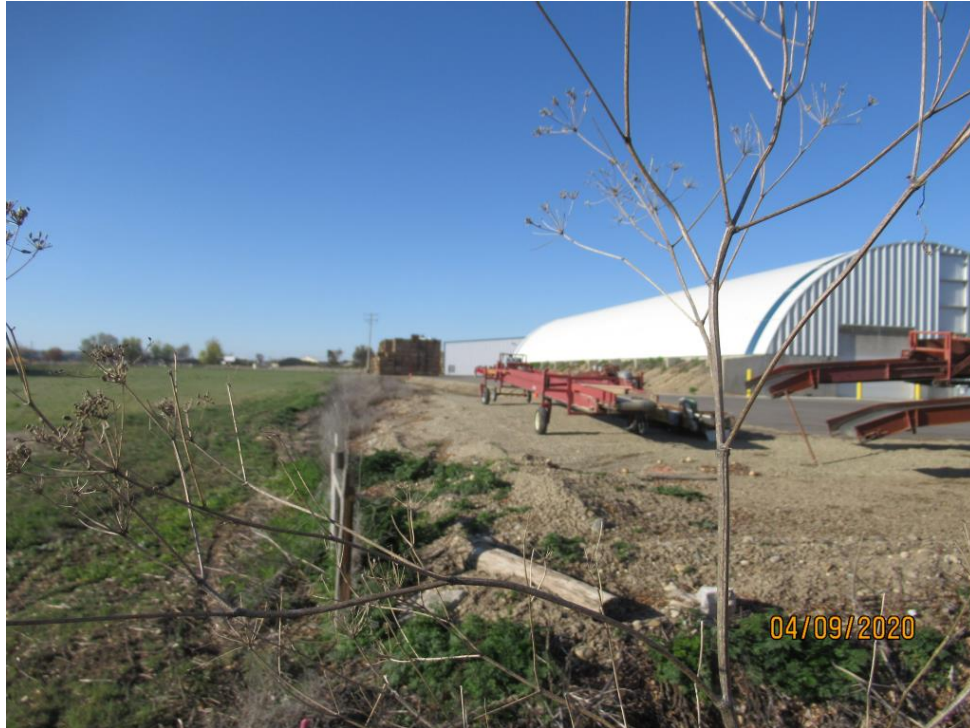
Photograph 1 :Stormwater swale located on the northeast side of the facility, looking south.

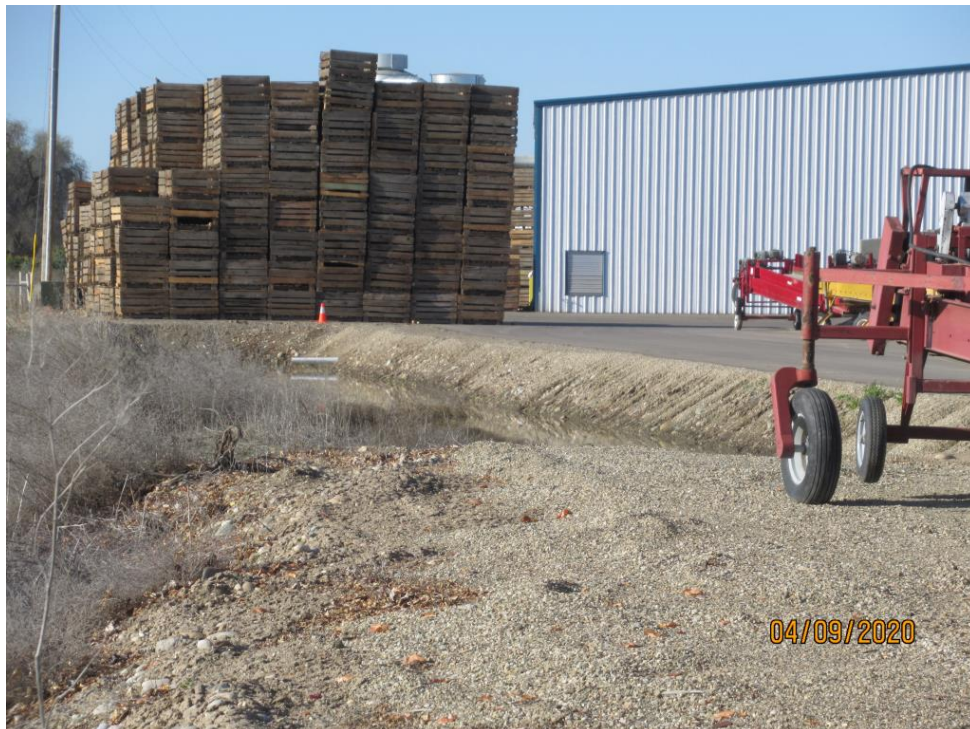
Photograph 2 :Close up view of stormwater swale located on the northeast side of the facility, looking south.

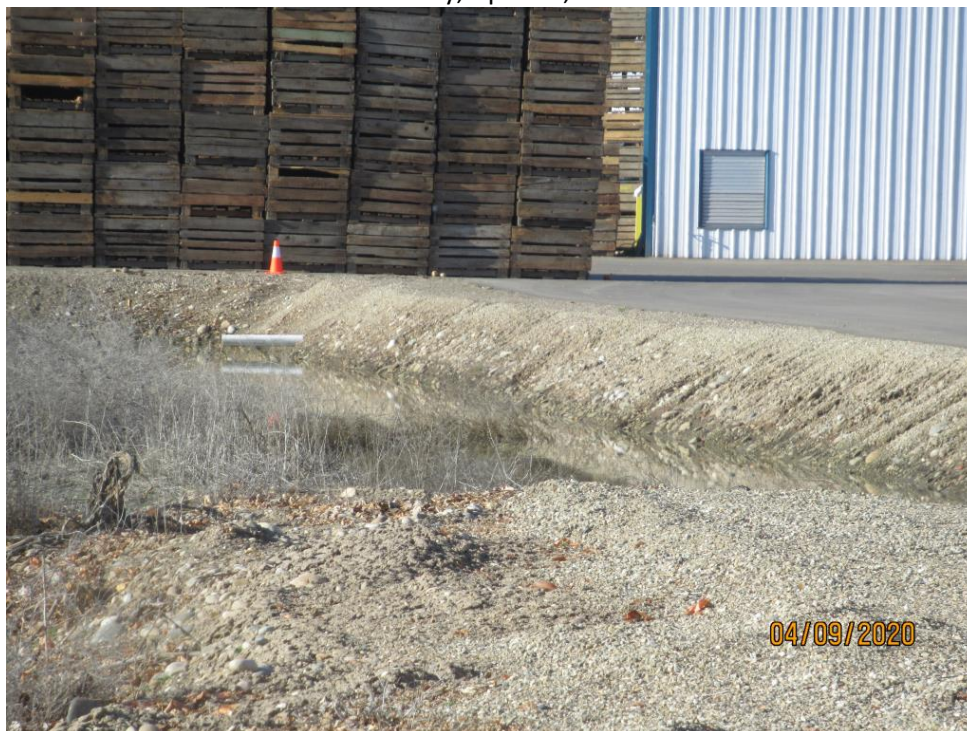
Photograph 3 :Close up view of outfall pipe to stormwater swale located on the northeast side of the facility, looking south.

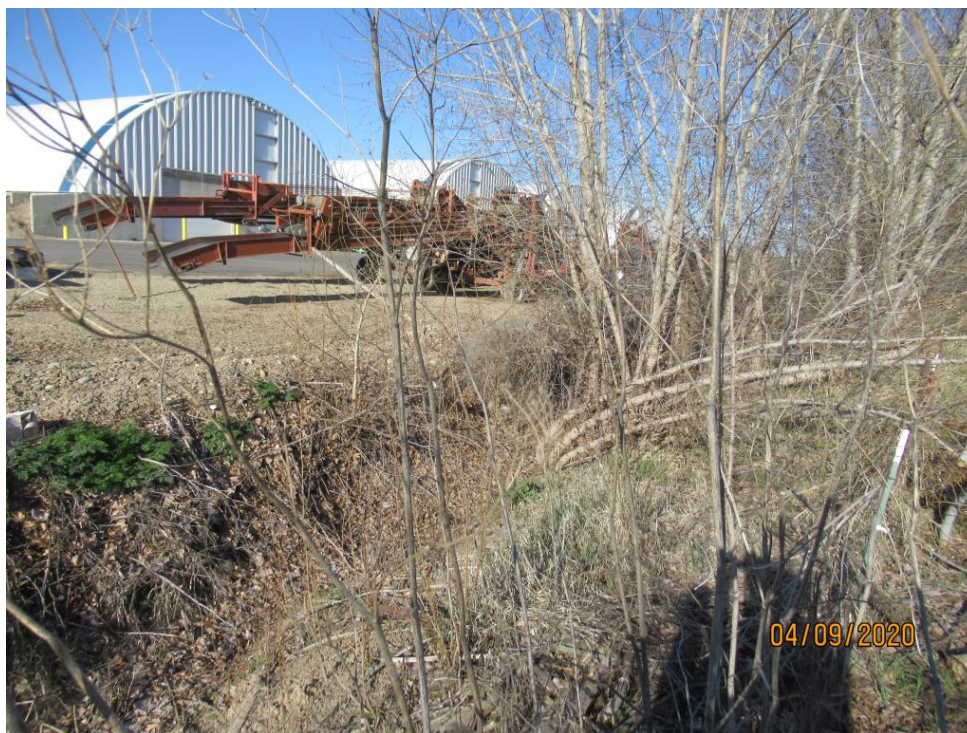
Photograph 4 :Irrigation ditch located on the north side of the facility, looking west.

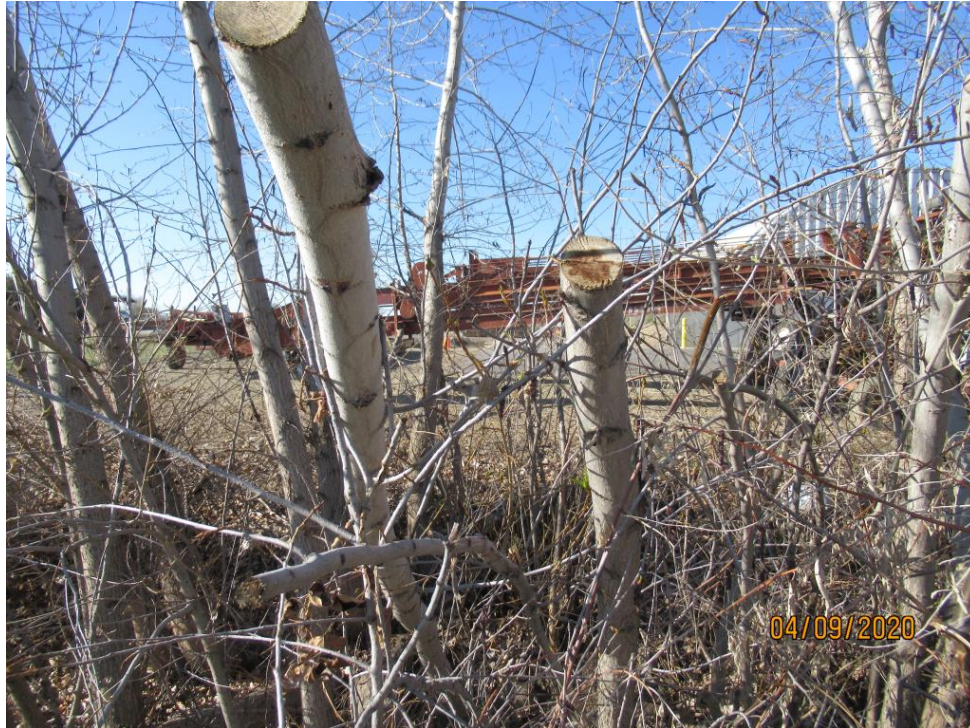
Photograph 5 :View of the stormwater swale located on the northeast side of the facility, looking through vegetation facing south. Filming location for video\_1 in complaint file #160717.

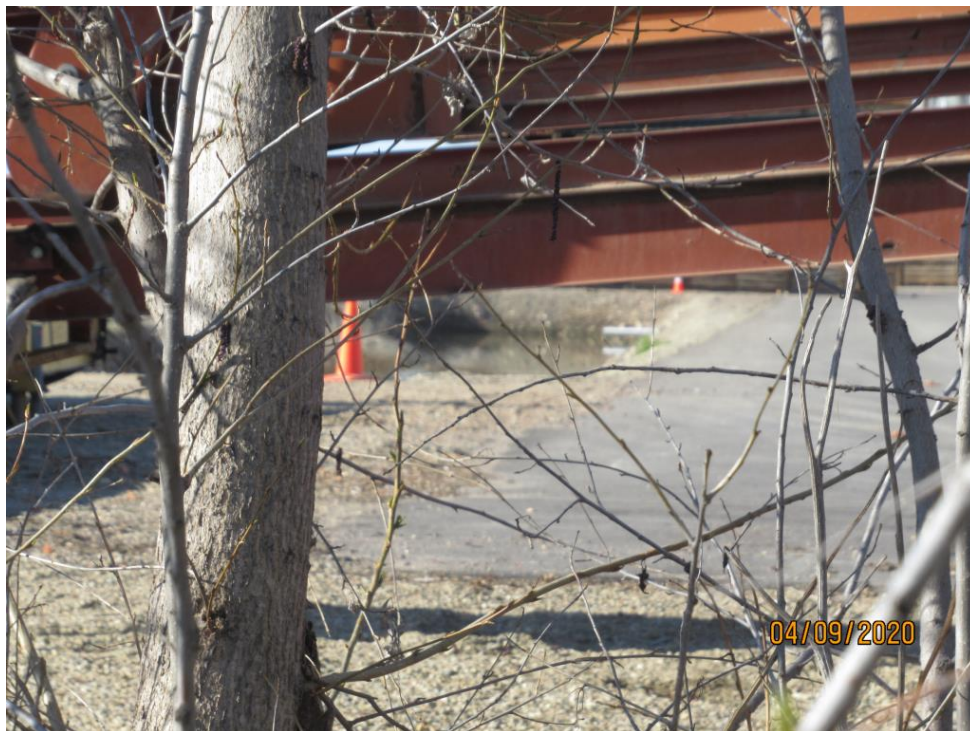
Photograph 6 :Close-up view of the stormwater swale located on the northeast side of the facility, looking through vegetation facing south.

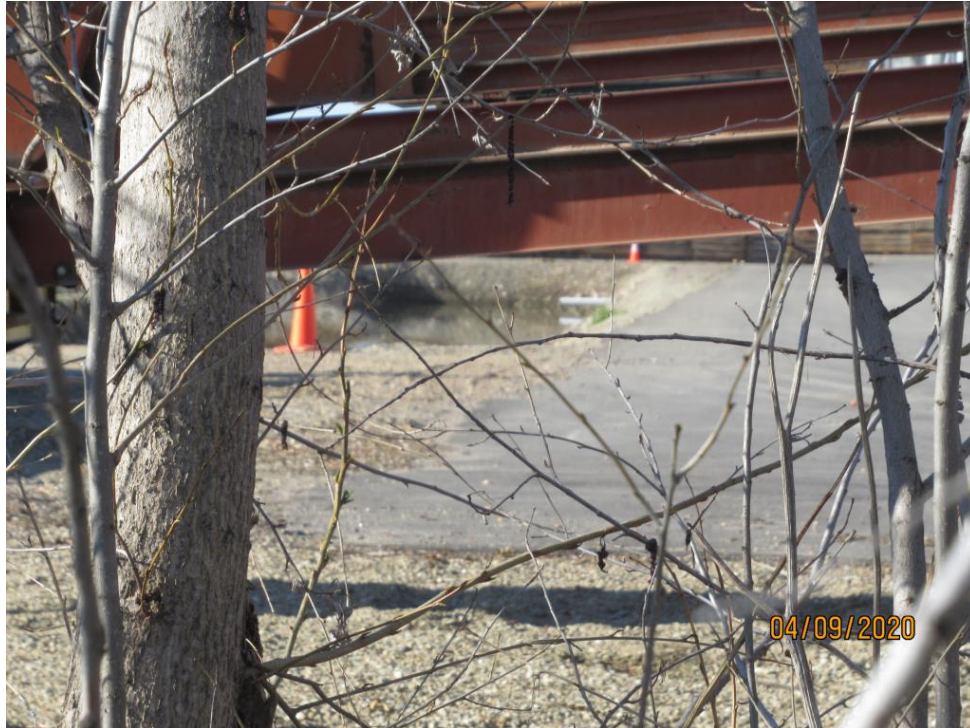
Photograph 7 :Second close-up view of the stormwater swale located on the northeast side of the facility, looking through vegetation facing south.

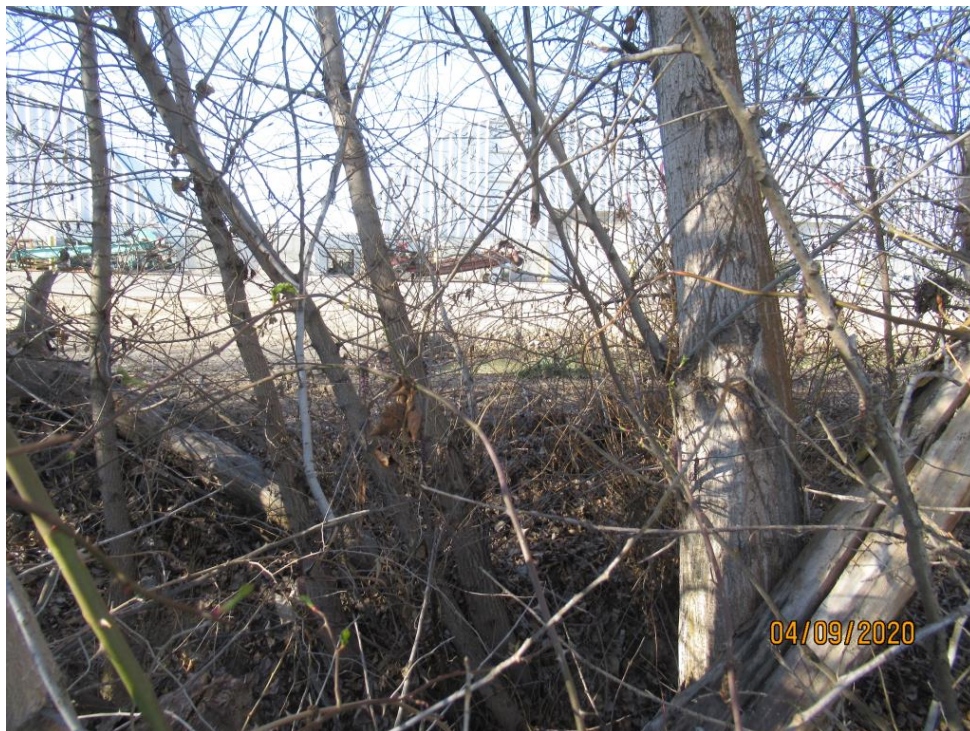
Photograph 8 :Stormwater swale located on the north side of the facility, looking through vegetation facing south.

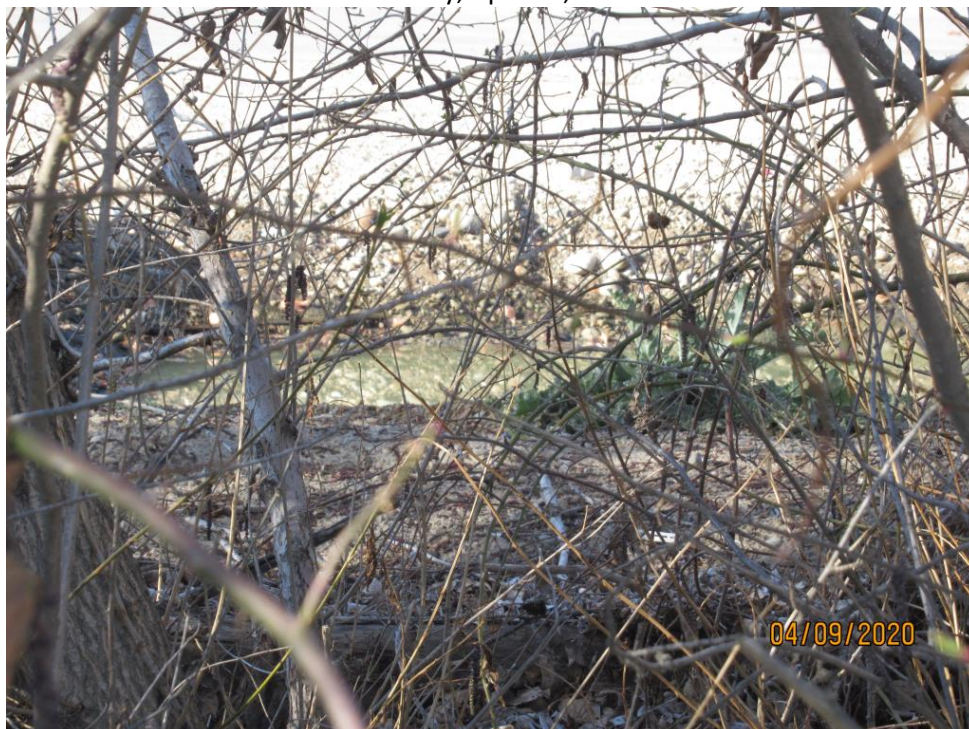
Photograph 9 :Close-up view of stormwater swale located on the north side of the facility, looking through vegetation facing south.

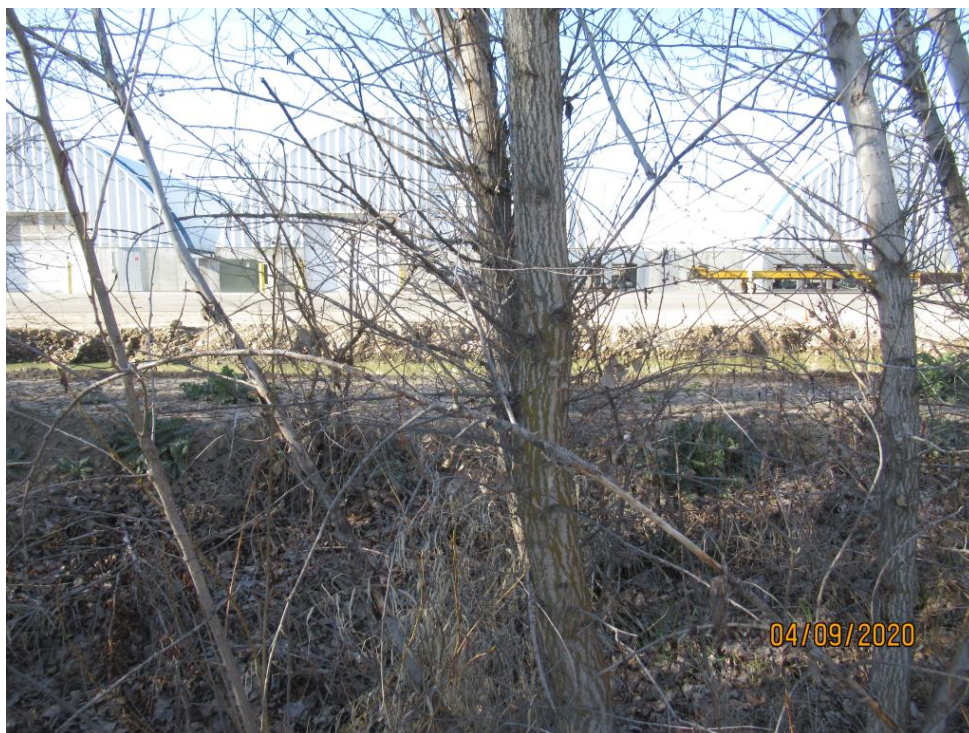
Photograph 10 :Stormwater swale, through vegetation, north side of the facility, looking at the central area facing south.

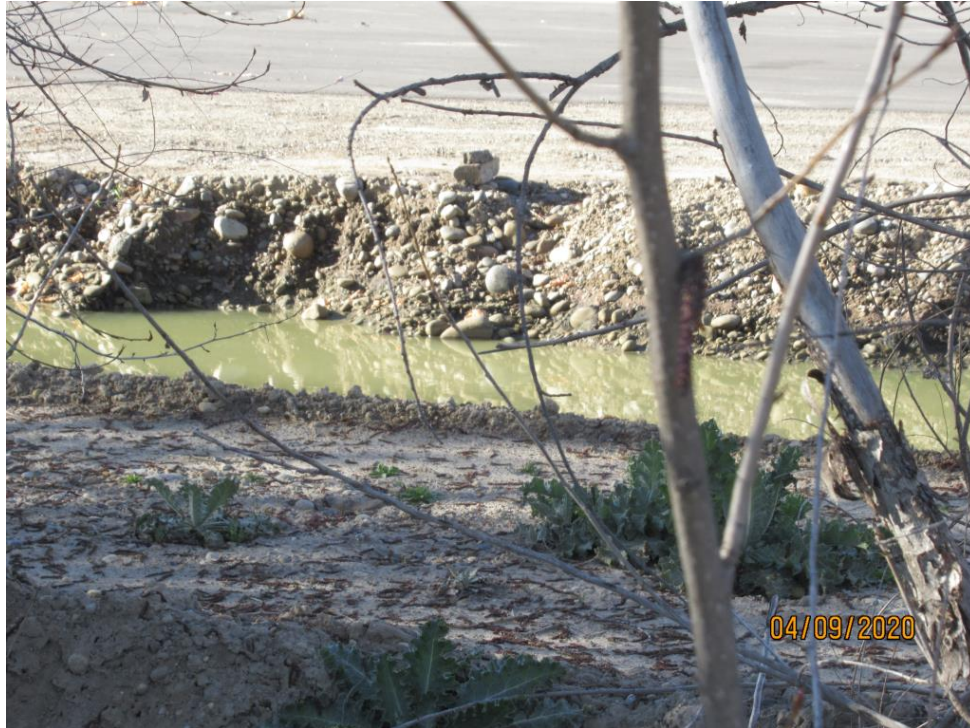
Photograph 11 :Close-up view of stormwater swale, through vegetation, north side of the facility, looking at the central area facing south.

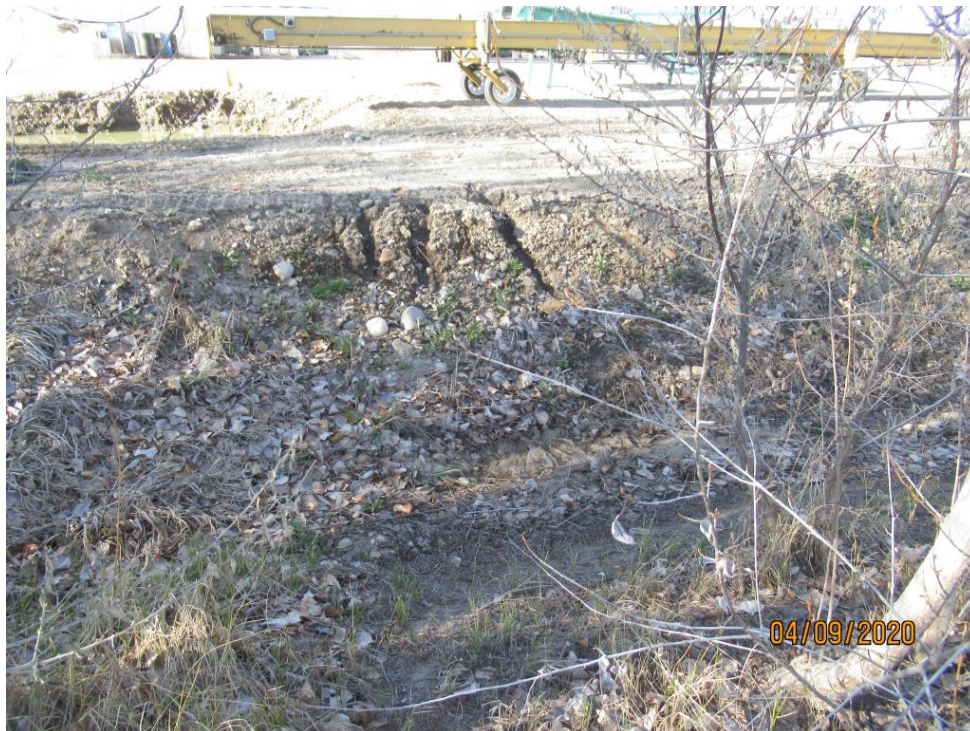
Photograph 12 :Rills on the north side of the facility, irrigation ditch is in the foreground, looking south.

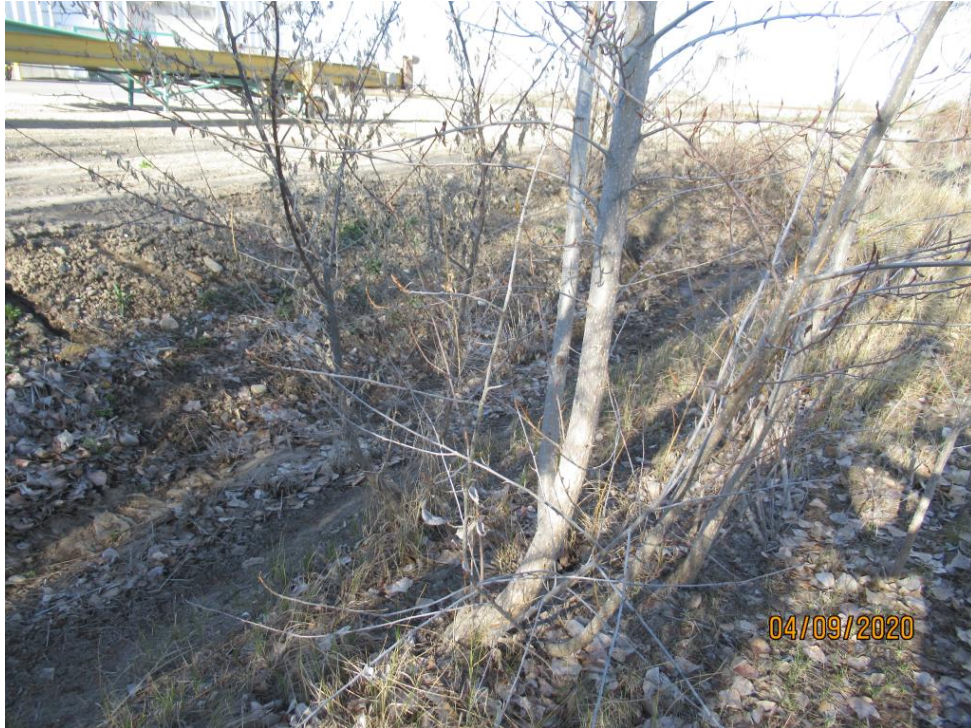
Photograph 13 :Irrigation ditch on north side of the property, looking west.

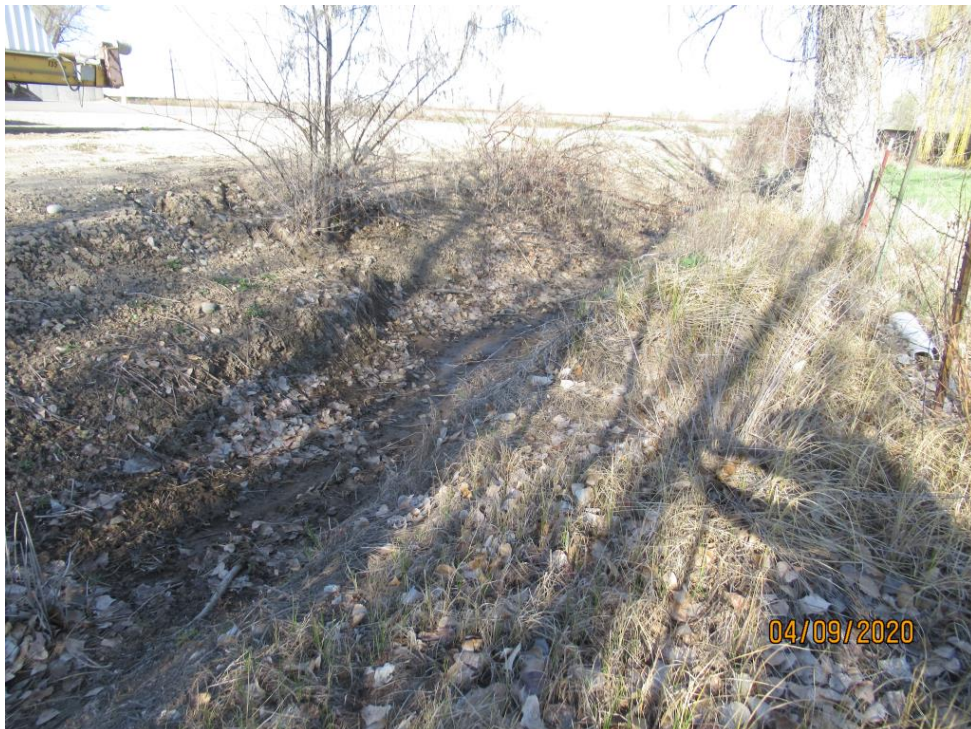
Photograph 14 :Irrigation ditch on north side of the property, looking west, moist soil in bottom of irrigation ditch.

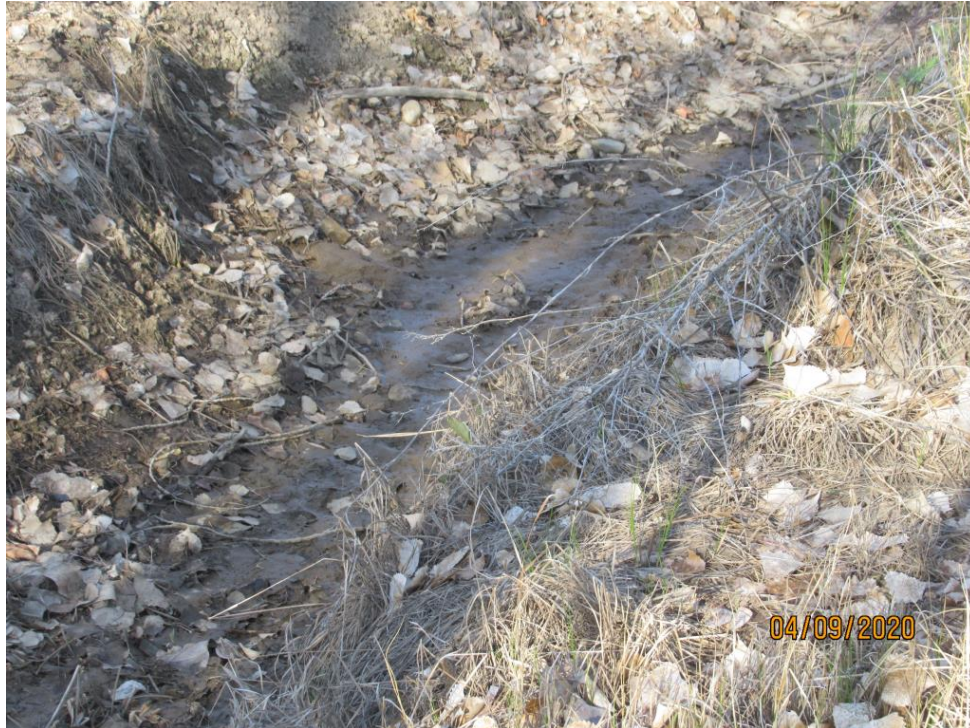
Photograph 15 :Close-up view of irrigation ditch on north side of the property, looking west, moist soil in bottom of irrigation ditch.

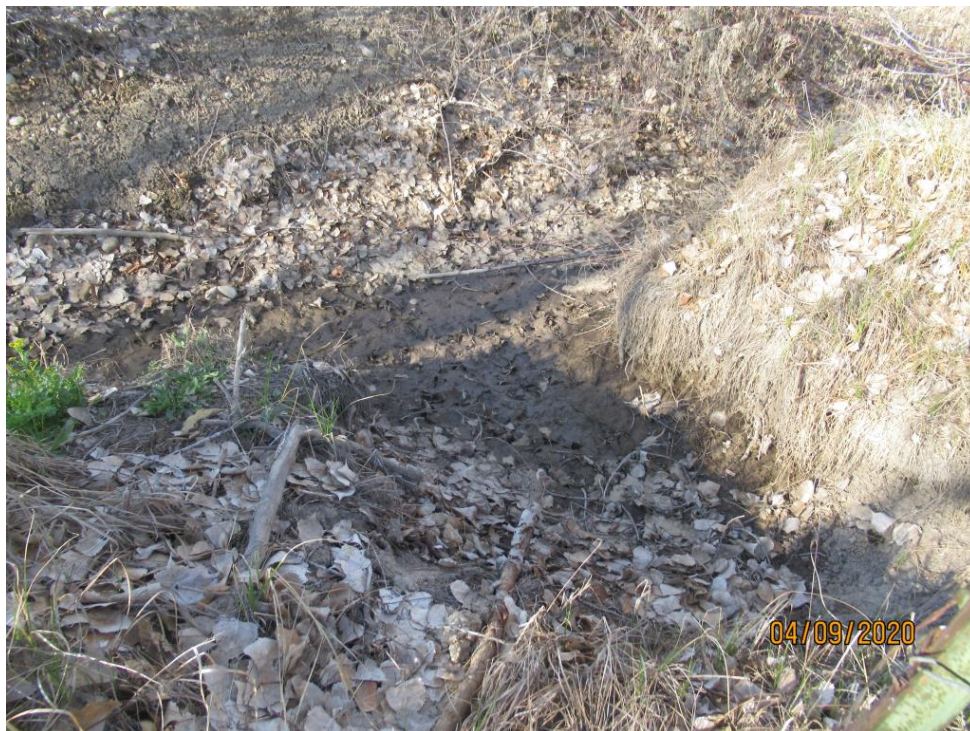
Photograph 16 :Irrigation ditch area observed in video attached to complaint file, Complaint #160717 Video.mov.

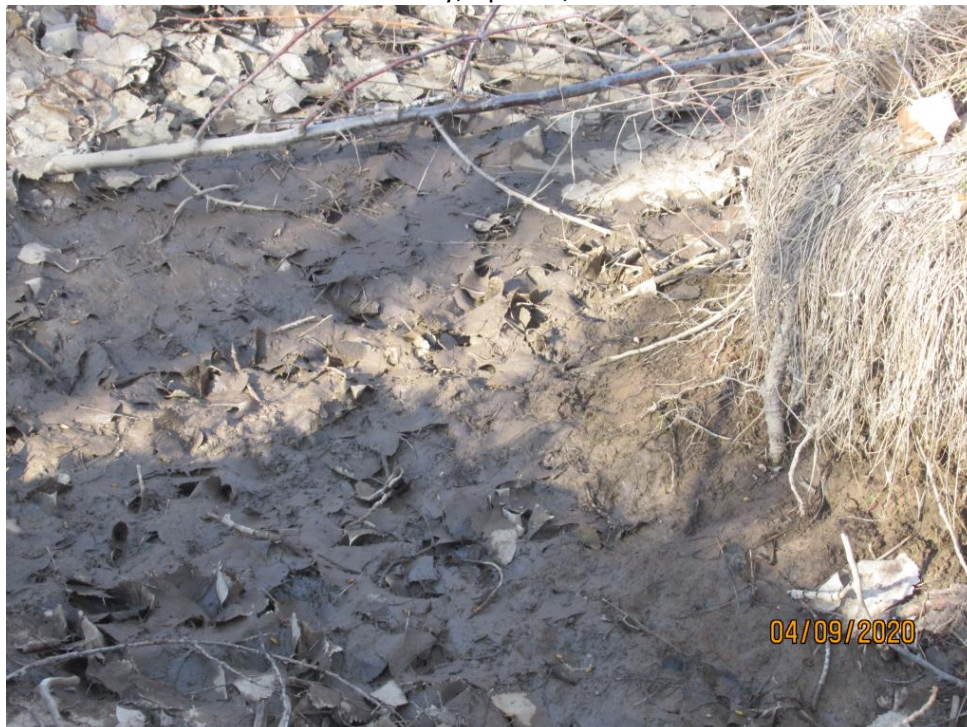
Photograph 17 :Close-up view of irrigation ditch area observed in video attached to complaint file, Complaint #160717 Video.mov.

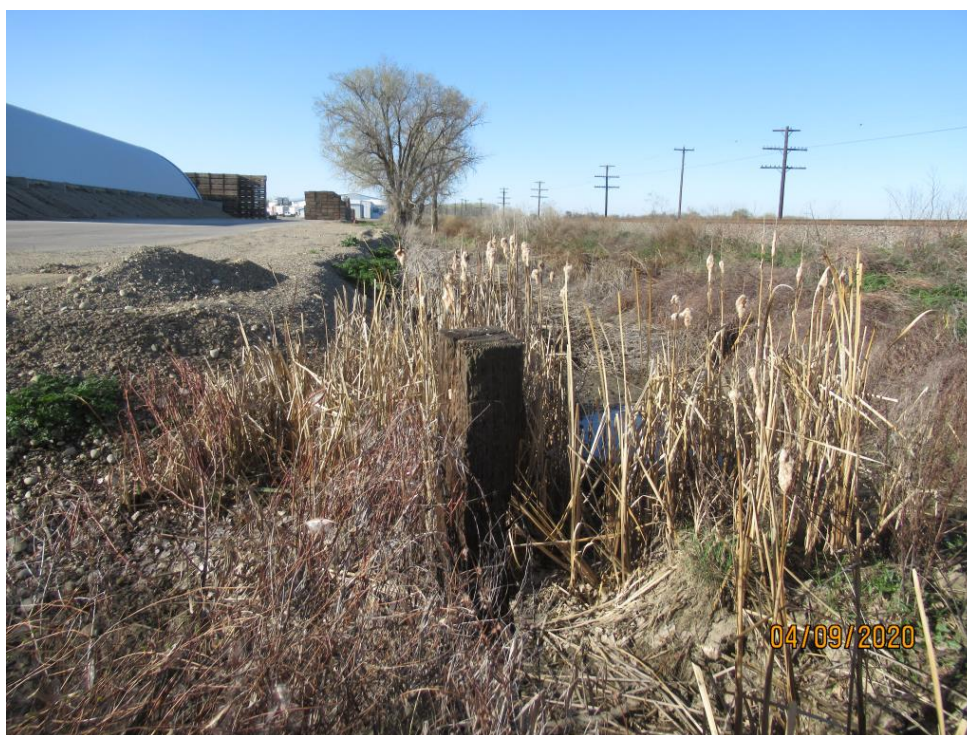
Photograph 18 :Irrigation ditch on the west side of the property, north side and west side irrigation ditches meet in the foreground, looking southwest.

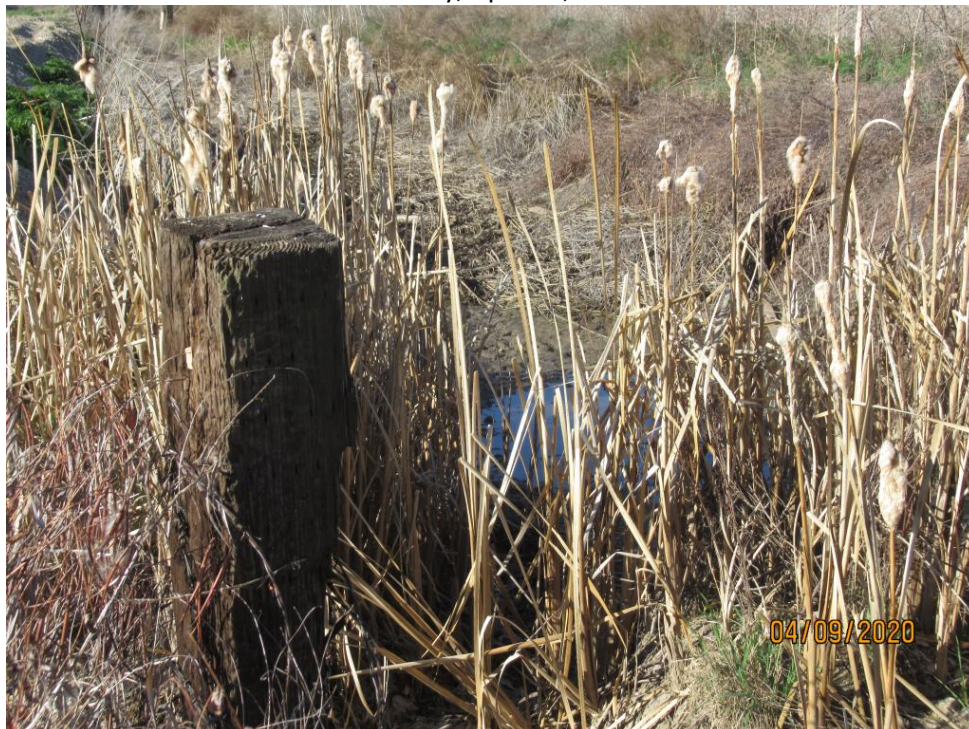
Photograph 19 :Close-up up view of pooling water in west side irrigation ditch, looking southwest.

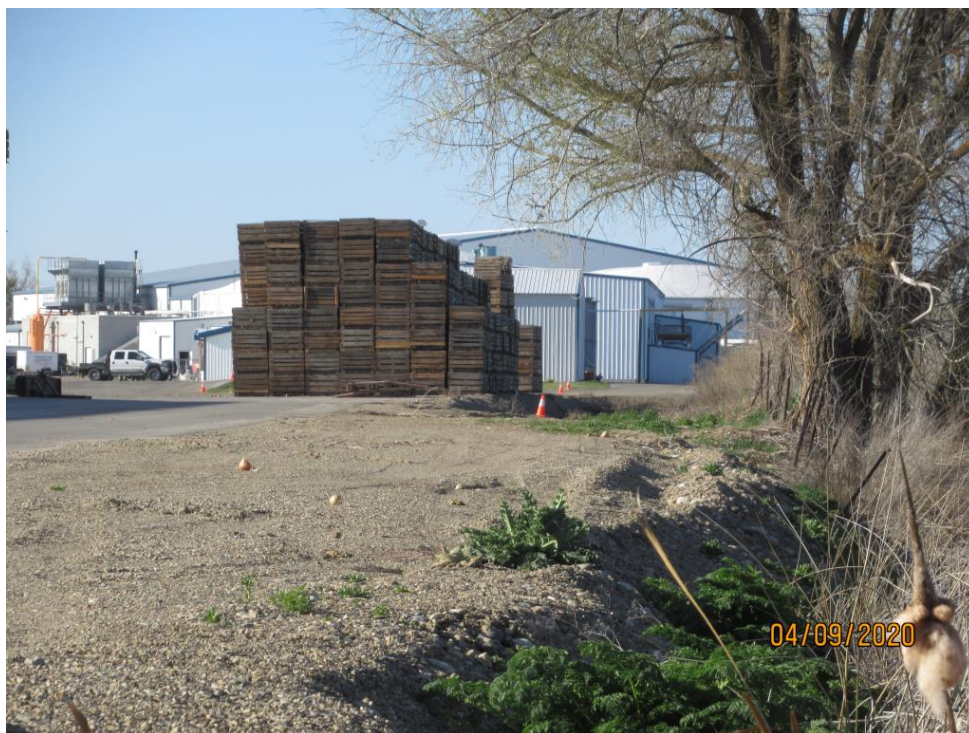
Photograph 20 :Stormwater swale located on the west side of the property, looking south.

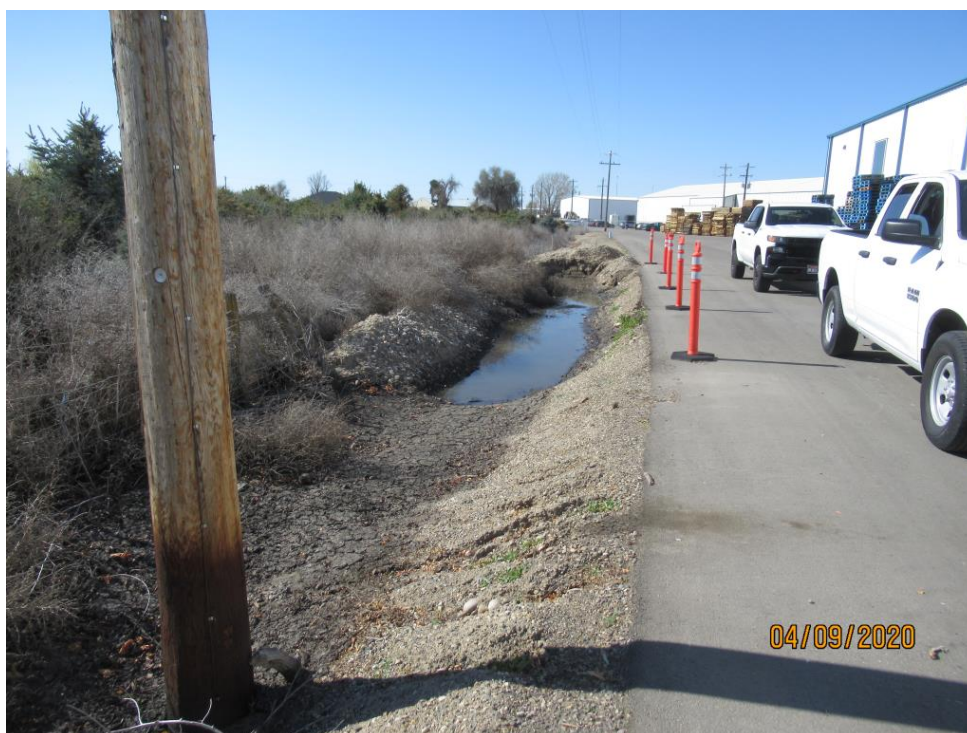
Photograph 22 :Stormwater swale, Swale #1, located on the east side of the property near the onion hopper from the largest building on the property. View is looking southwest

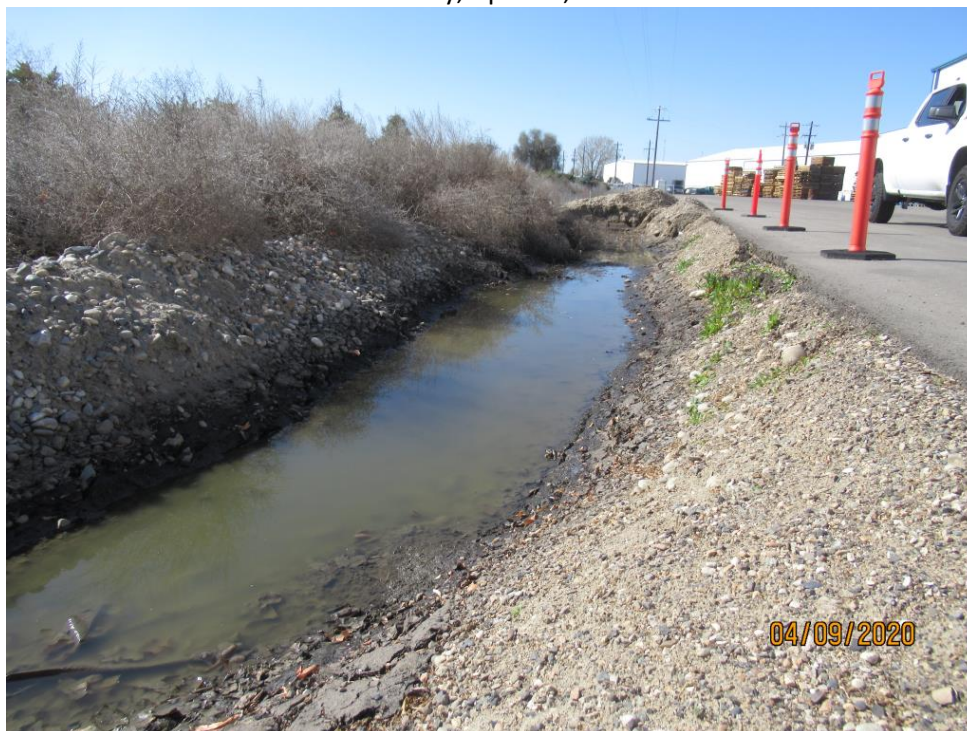
Photograph 23 :Close-up view of Swale #1, looking southwest.

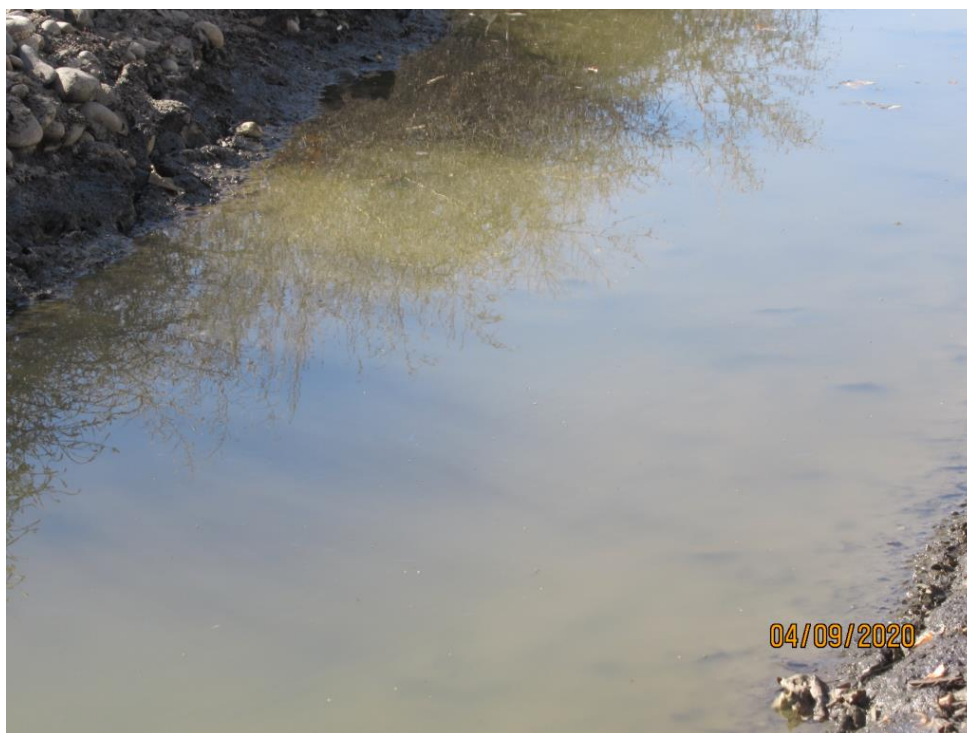
Photograph 24 :Water in Swale #1. Strong onion odor noticed in this area.

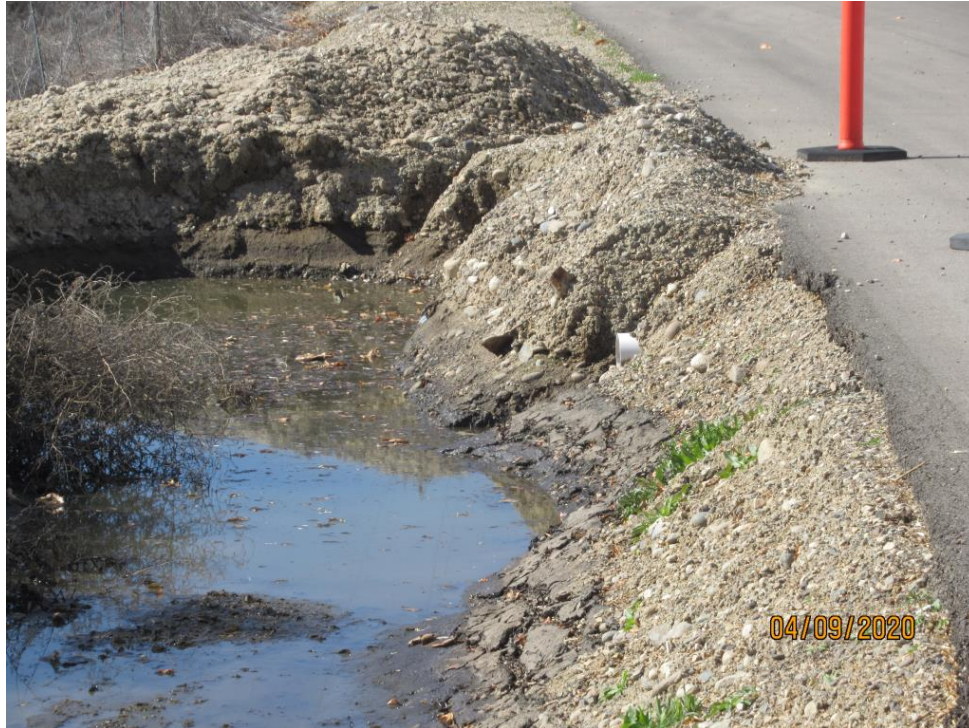
Photograph 25 :Stormwater outfall to Swale #1, looking southwest.

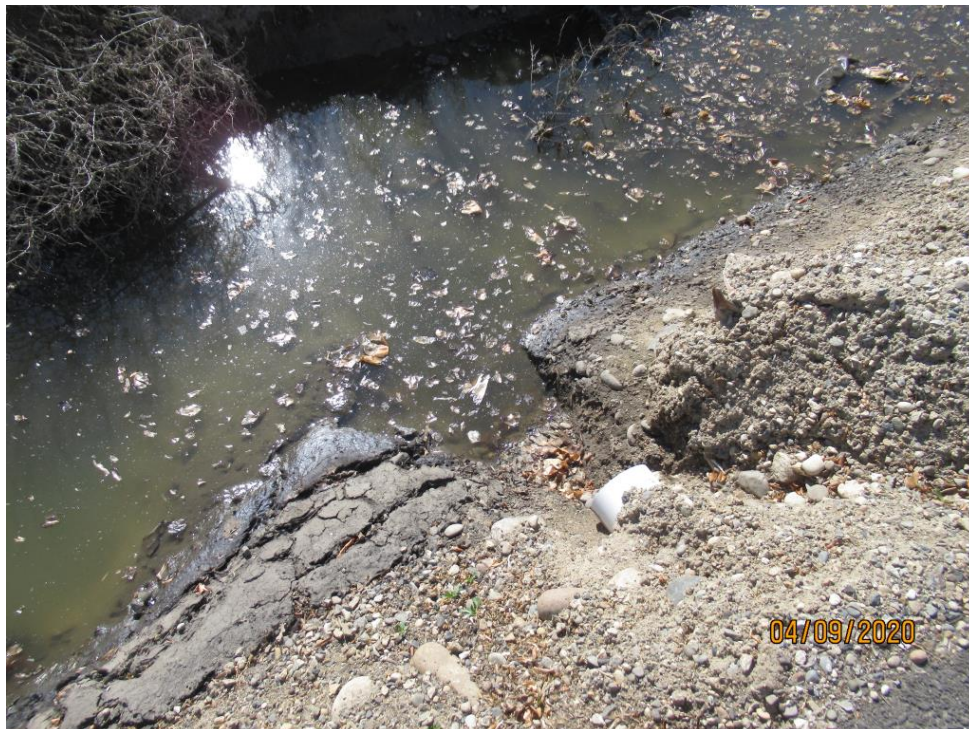
Photograph 26 :Stormwater outfall and water, Swale #1, note onion husk and debris in water.

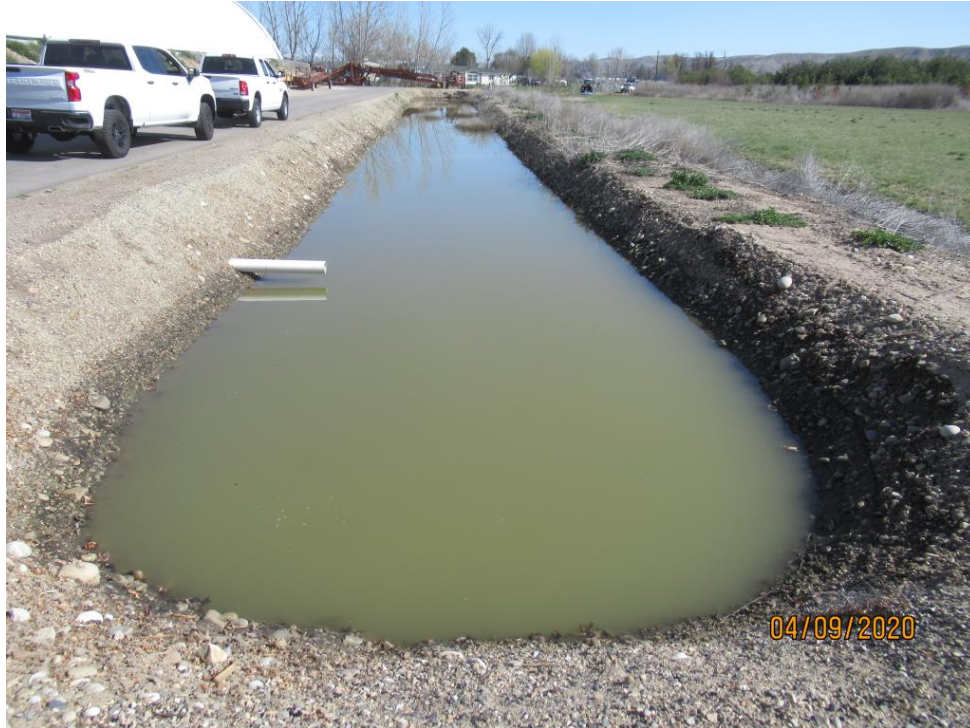
Photograph 27 :Stormwater swale, Swale #2, located on the northeast corner of the property, looking north northeast.

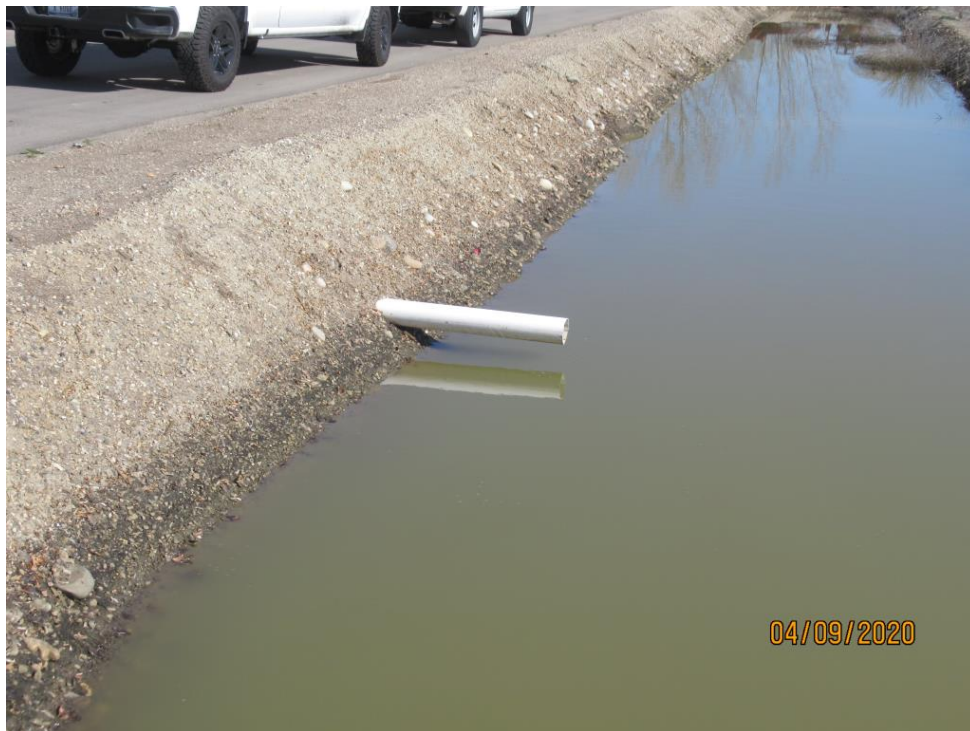
Photograph 28 :Stormwater outfall to Swale #2, looking north.

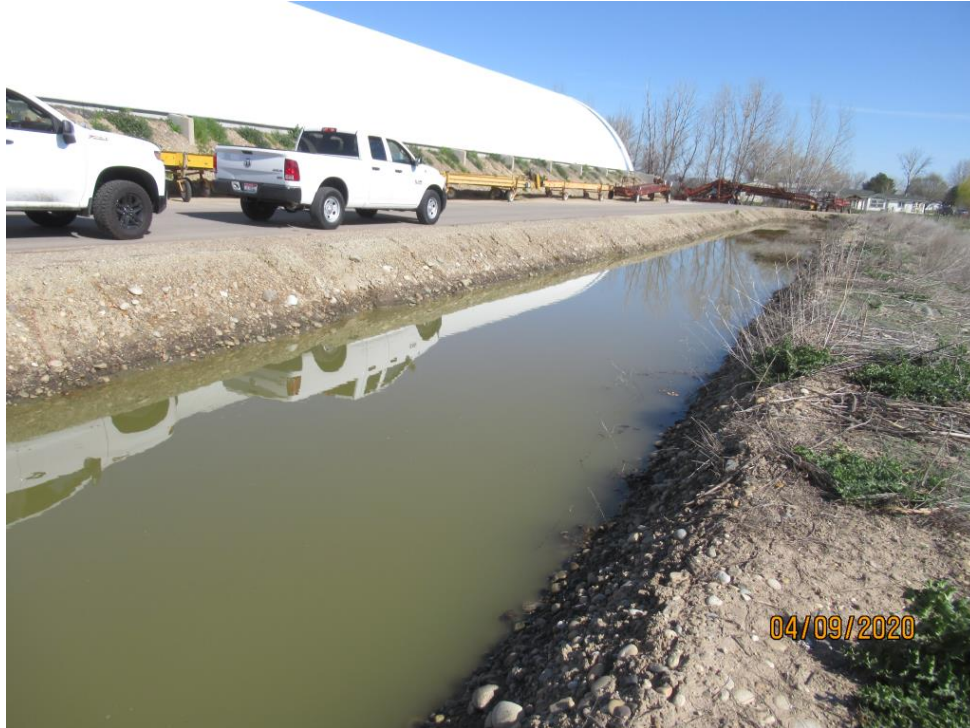
Photograph 29 :Swale #2, looking north.

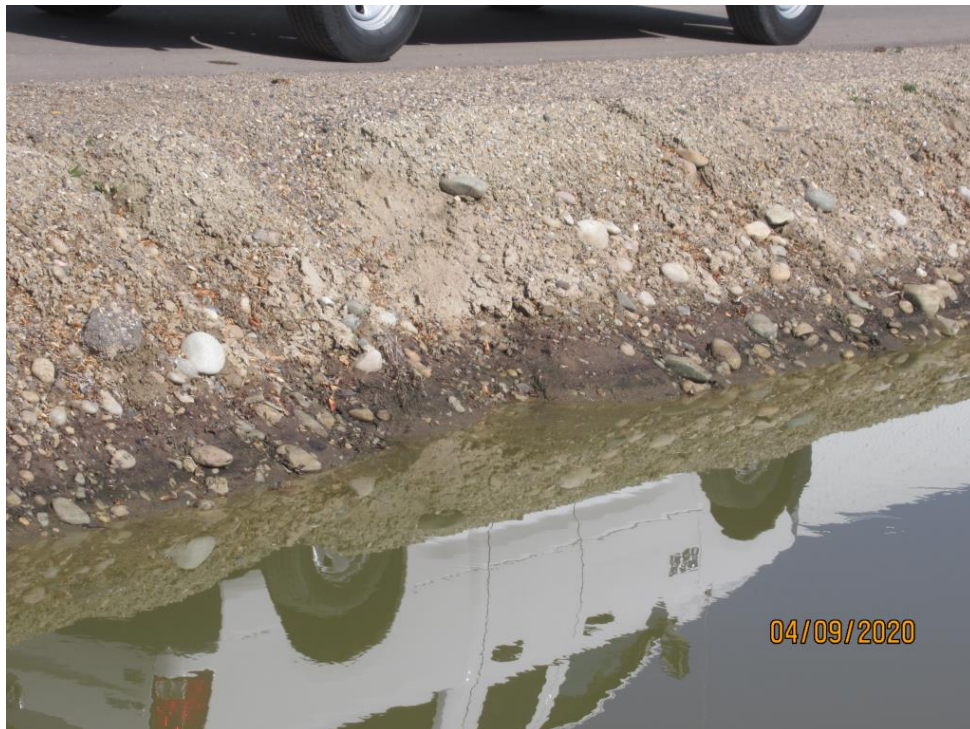
Photograph 30 :Rills on west bank of Swale #2 near south end of the swale.

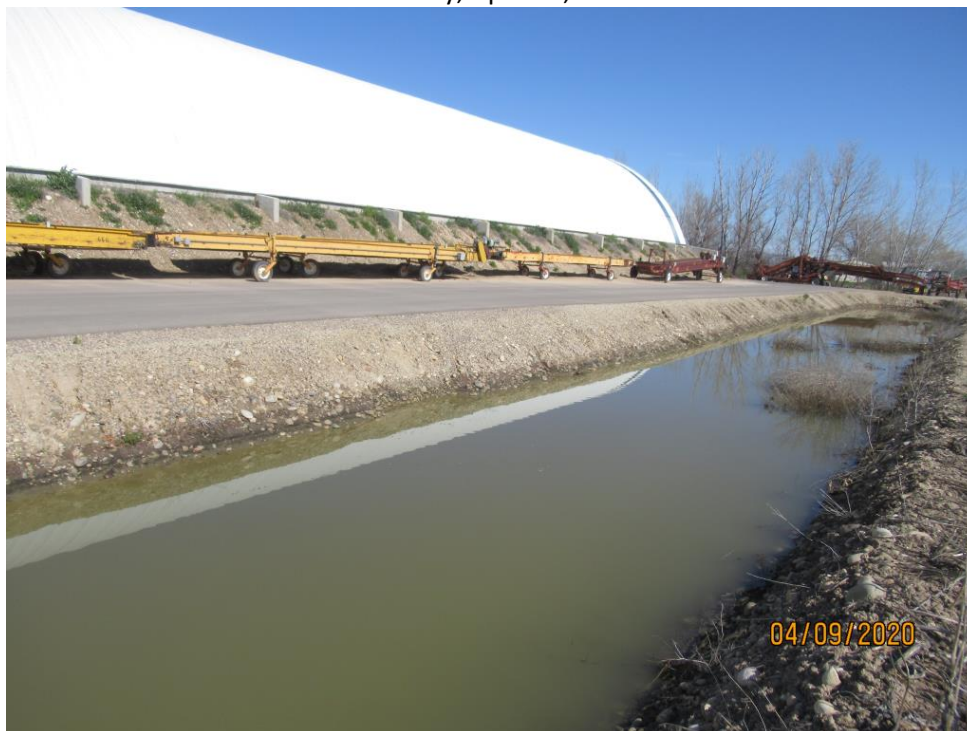
Photograph 31 :Swale #2, mid-way, looking north, note rills along west bank

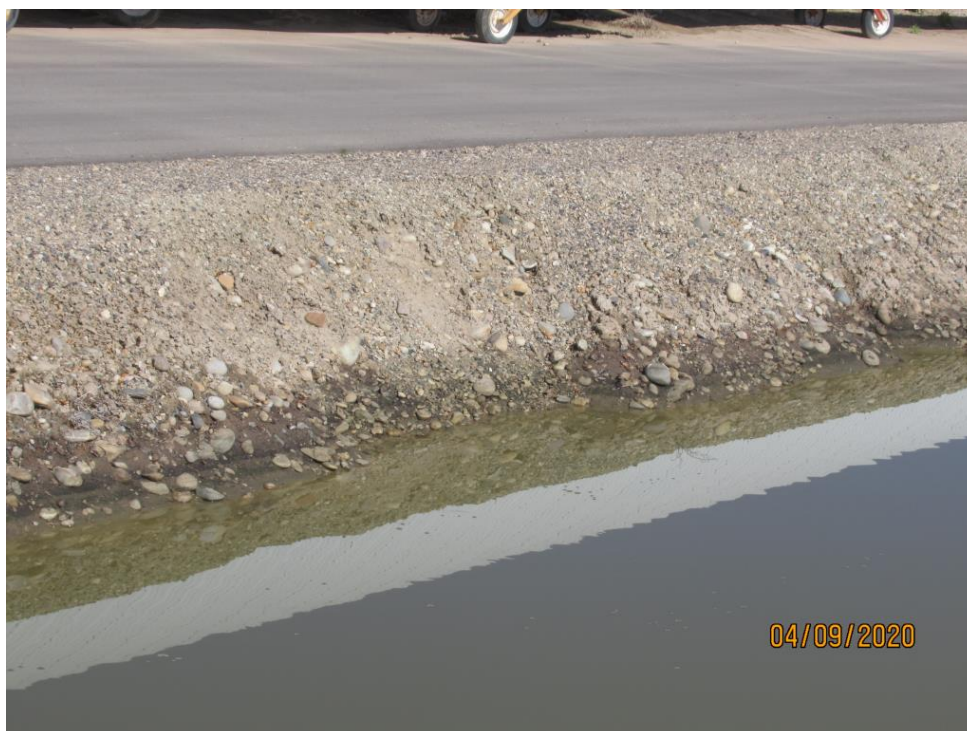
Photograph 32 :Close-up view of west bank rills, mid-way, Swale #2.
