## Photographic Documentation

**Name of Facility:** Partners Produce, Payette

**Inspection Date:** Thursday, April 09, 2020

**Purpose of Inspection:** Complaint investigation

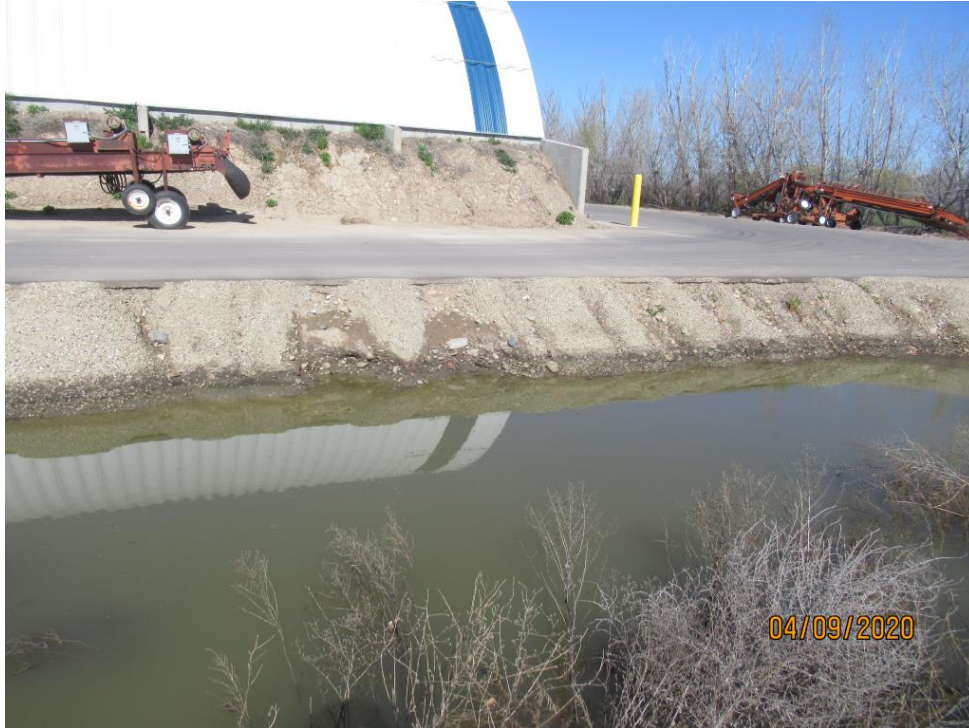
Photograph 33 :Swale #2, north end, looking northwest.

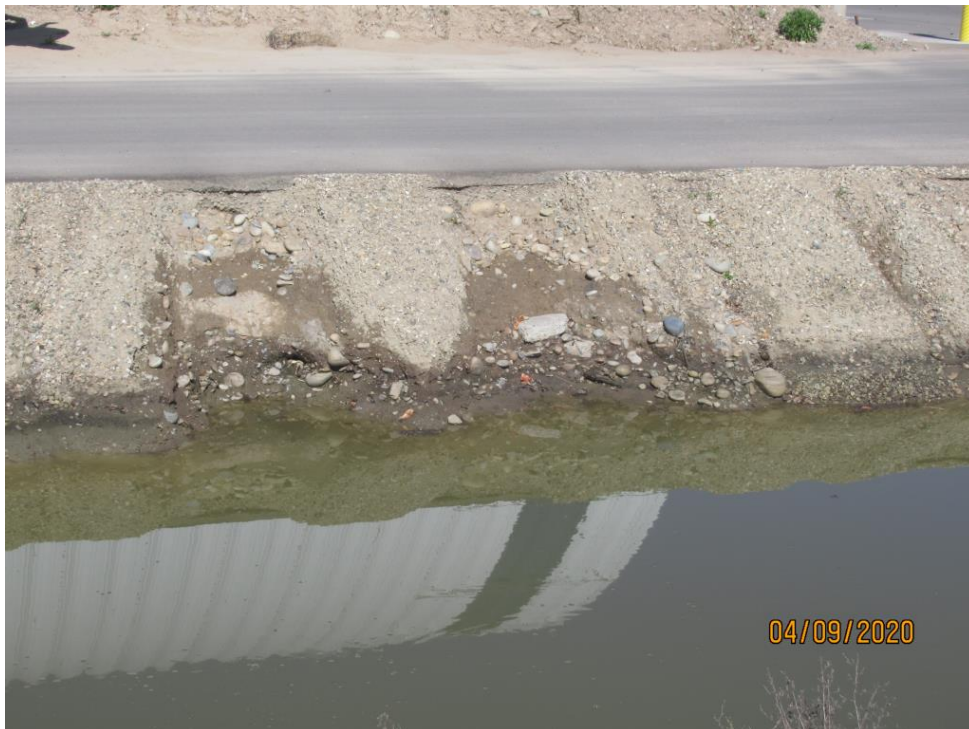
Photograph 34 :Close-up view of north end rills, Swale #2.

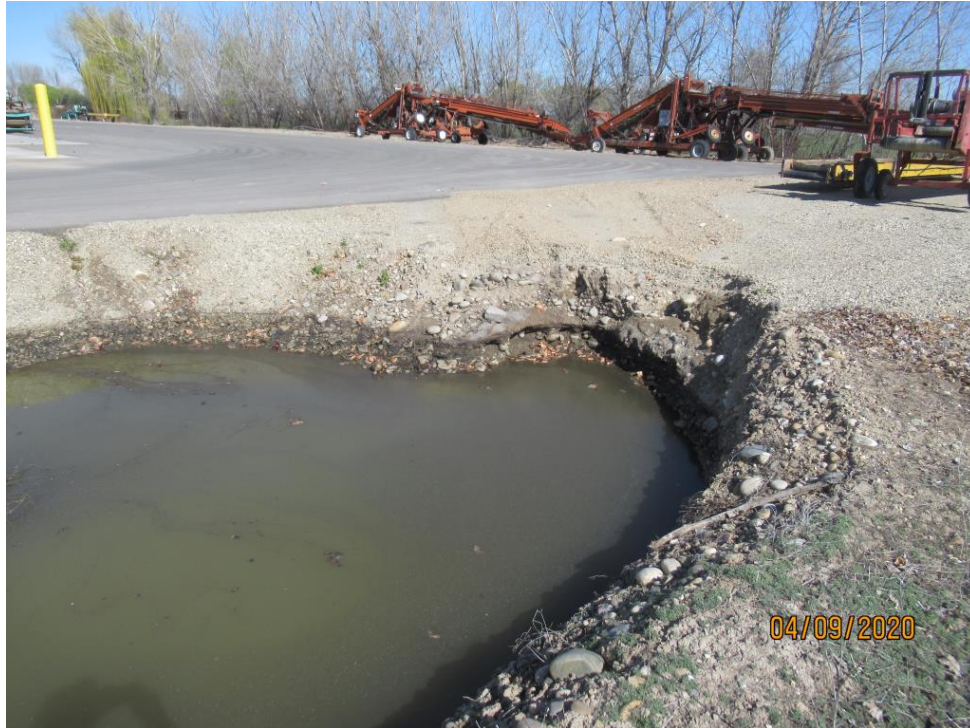
Photograph 35 :Swale #2, north end, looking north.

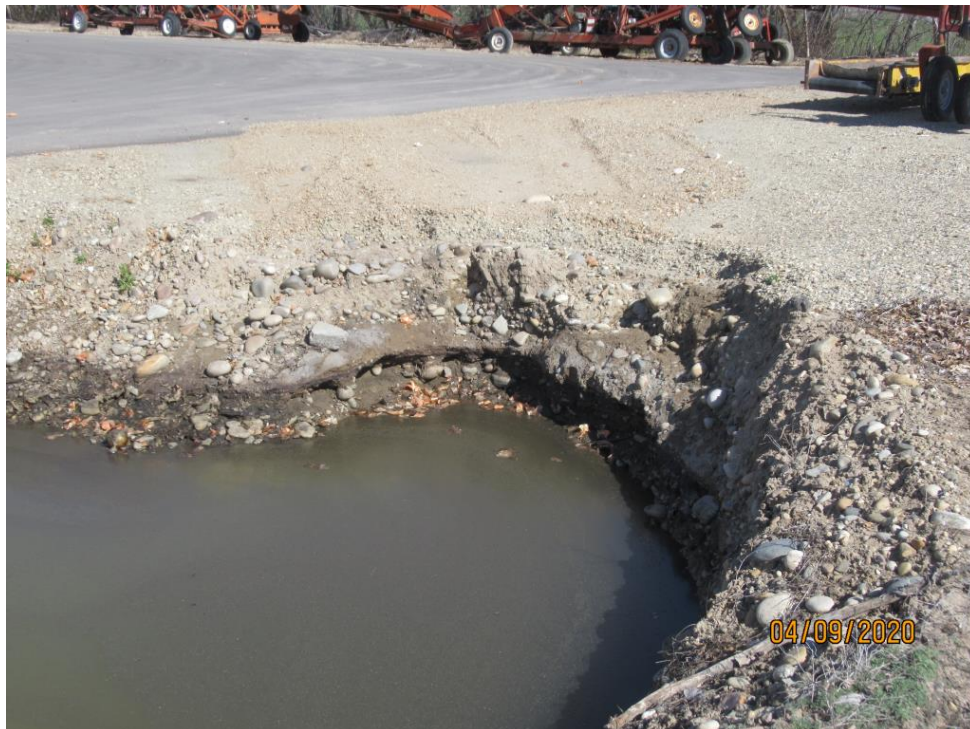
Photograph 36 :Close-up view of erosion area, Swale #2, north end.

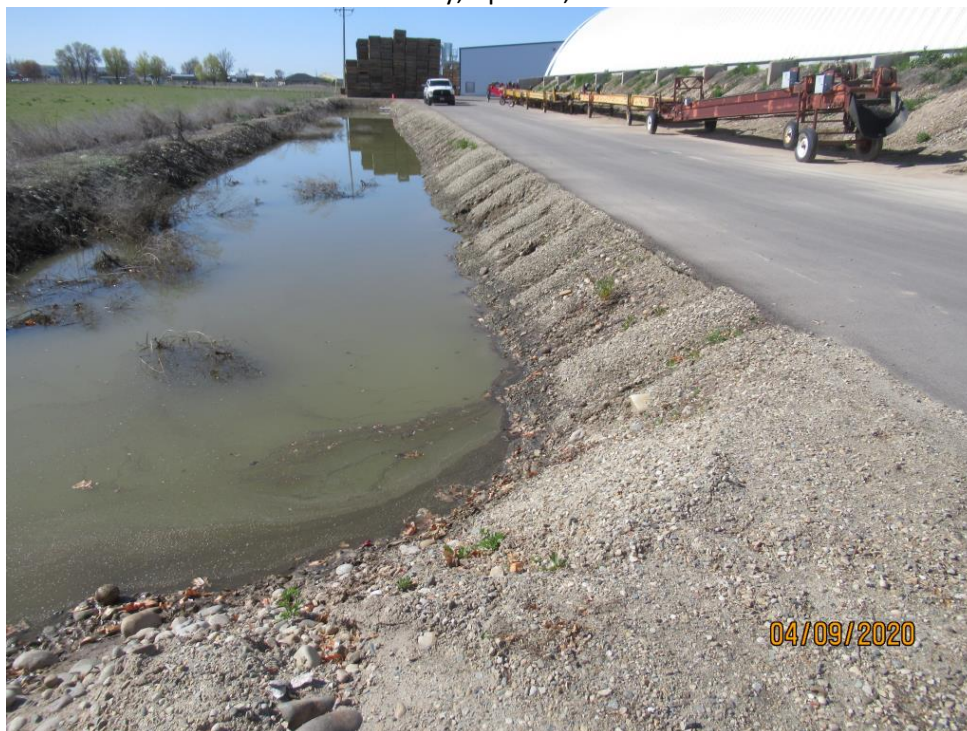
Photograph 37 :Swale #2, looking southwest. Strong onion odor noticed in this area.

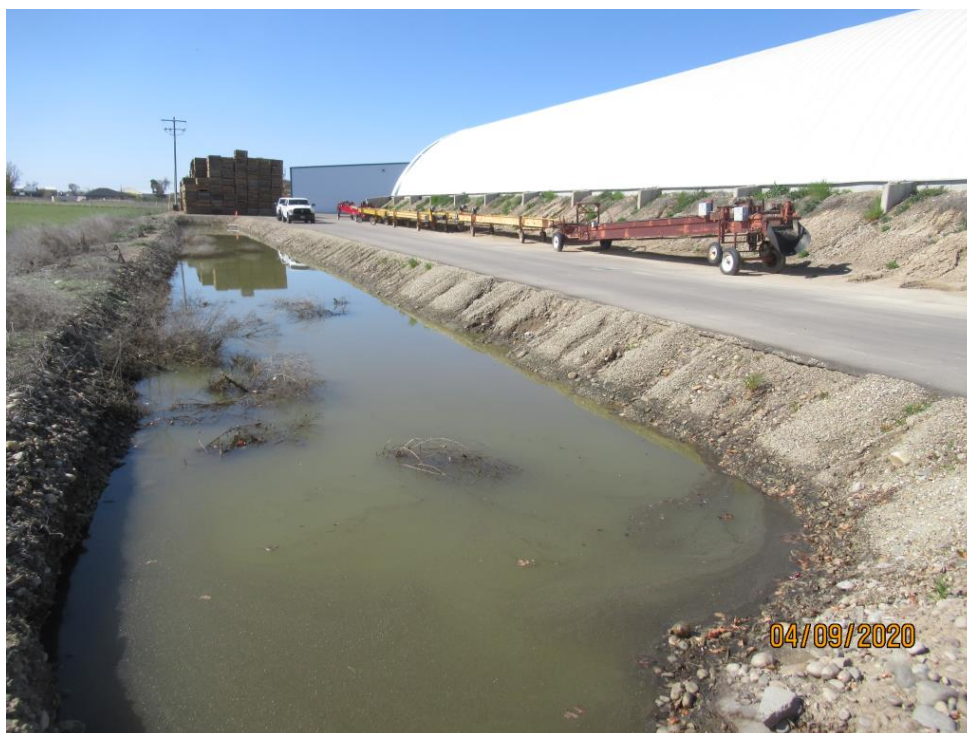
Photograph 38 :Swale #2, looking southwest, note rills on west bank.

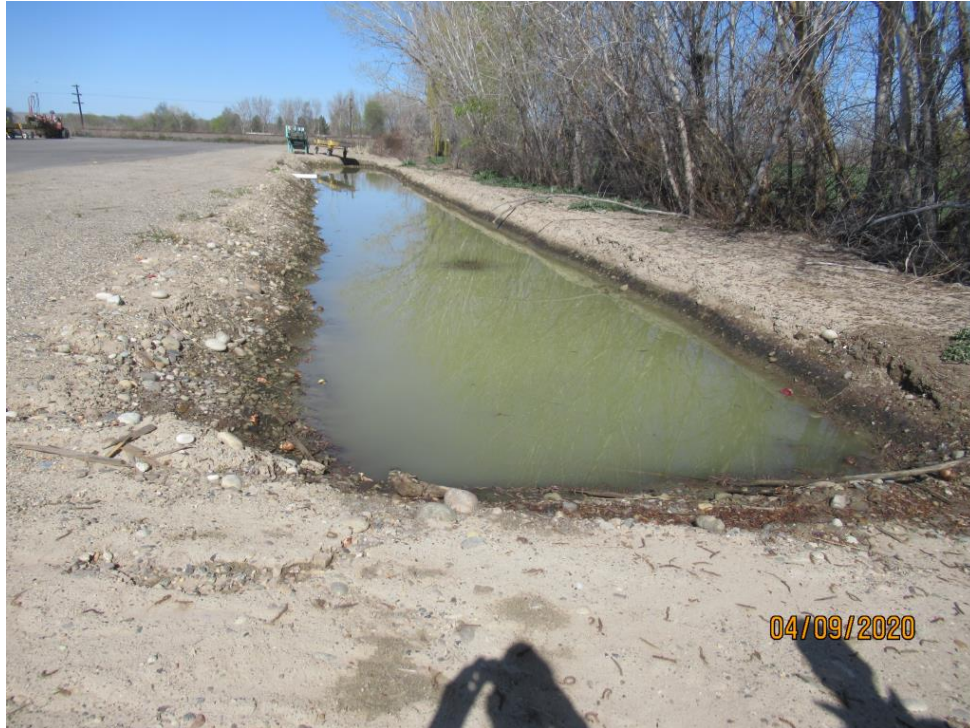
Photograph 39 :Stormwater swale, Swale #3, located on the north side of the property, looking northwest.

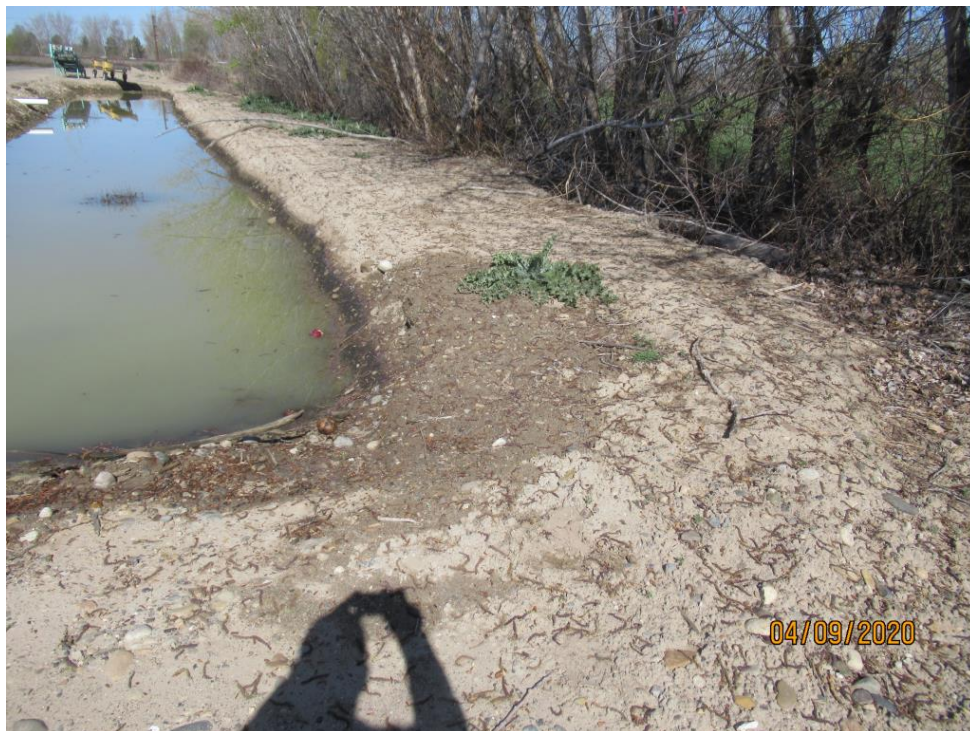
Photograph 40 :Swale #3, northeast end, looking northwest.

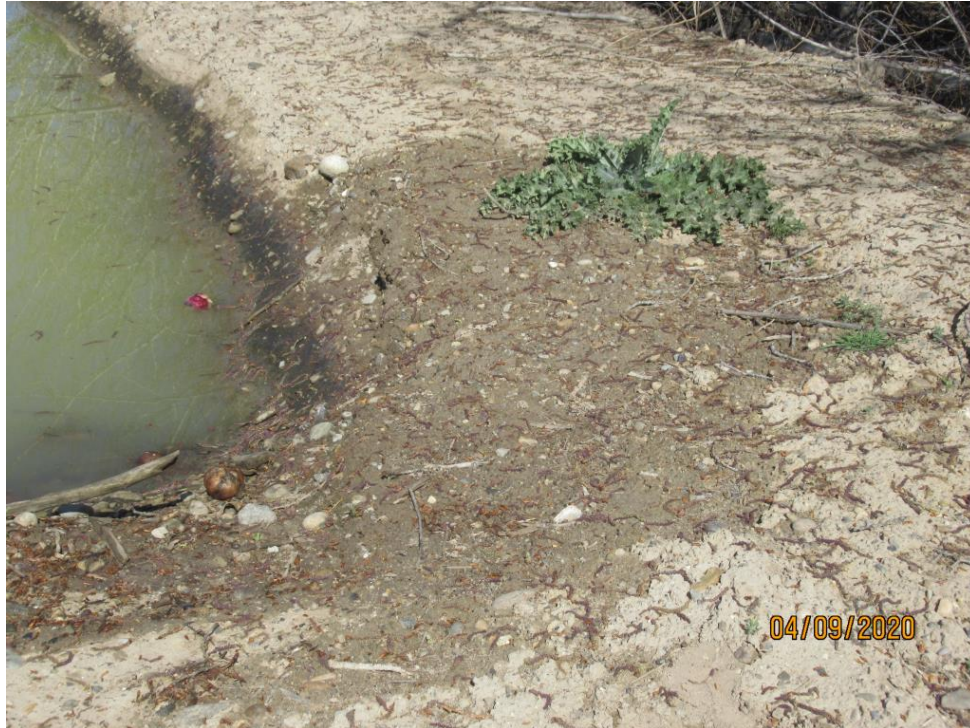
Photograph 41 :Close-up view of Swale #3, northeast end.

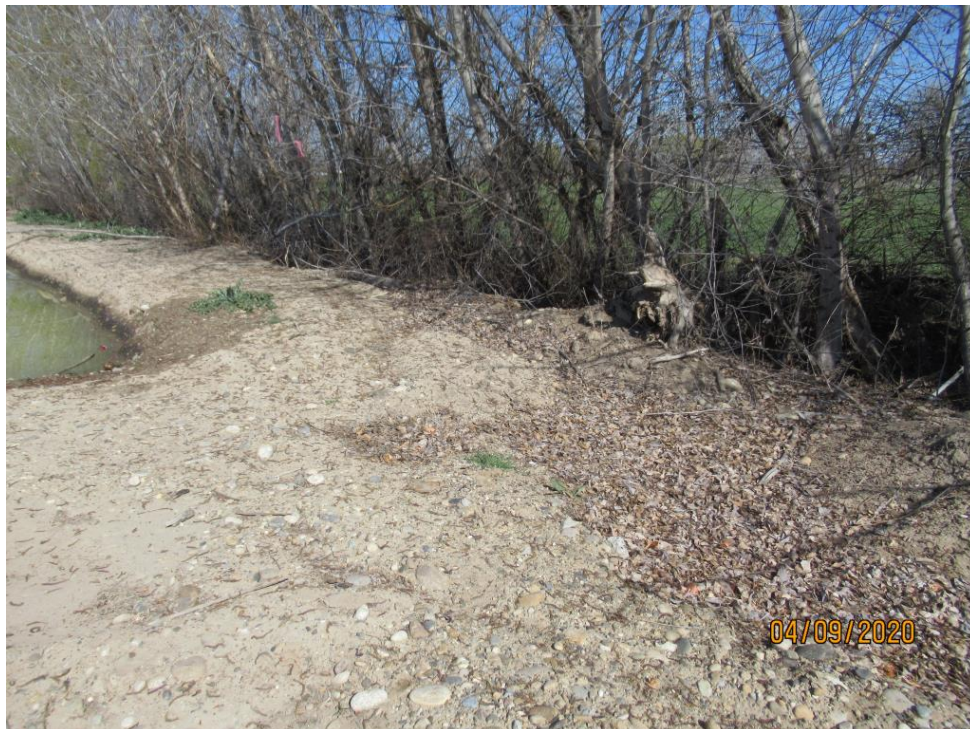
Photograph 42 :Irrigation ditch and vegetation on the north side of the property near Swale #3.

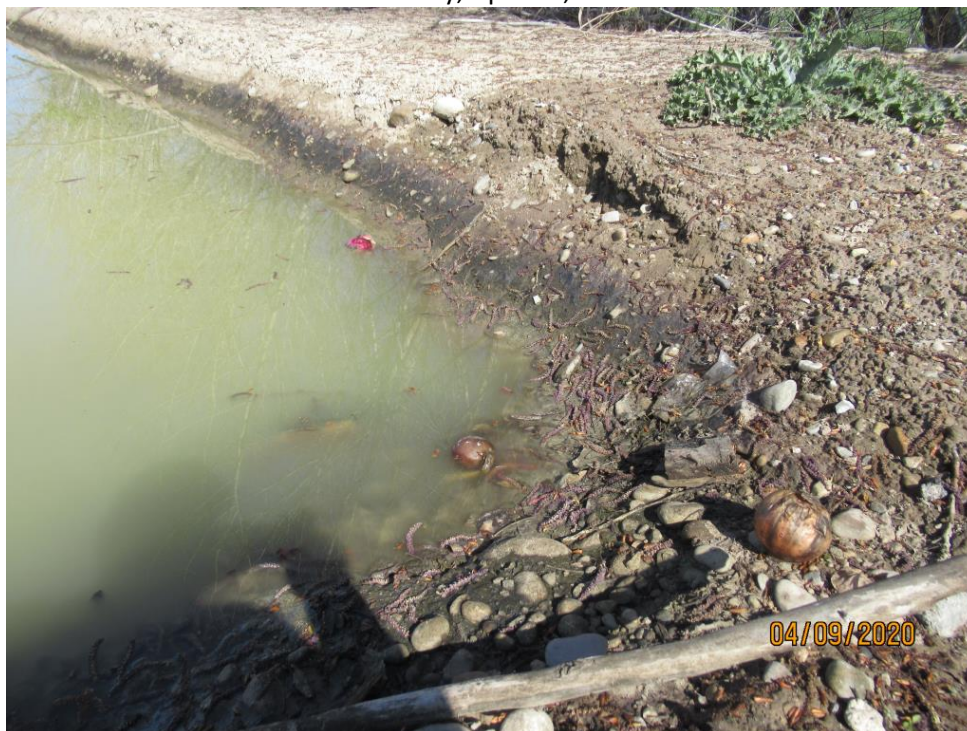
Photograph 43 :Close-up view of Swale #3, northeast end, note onion and onion husks.

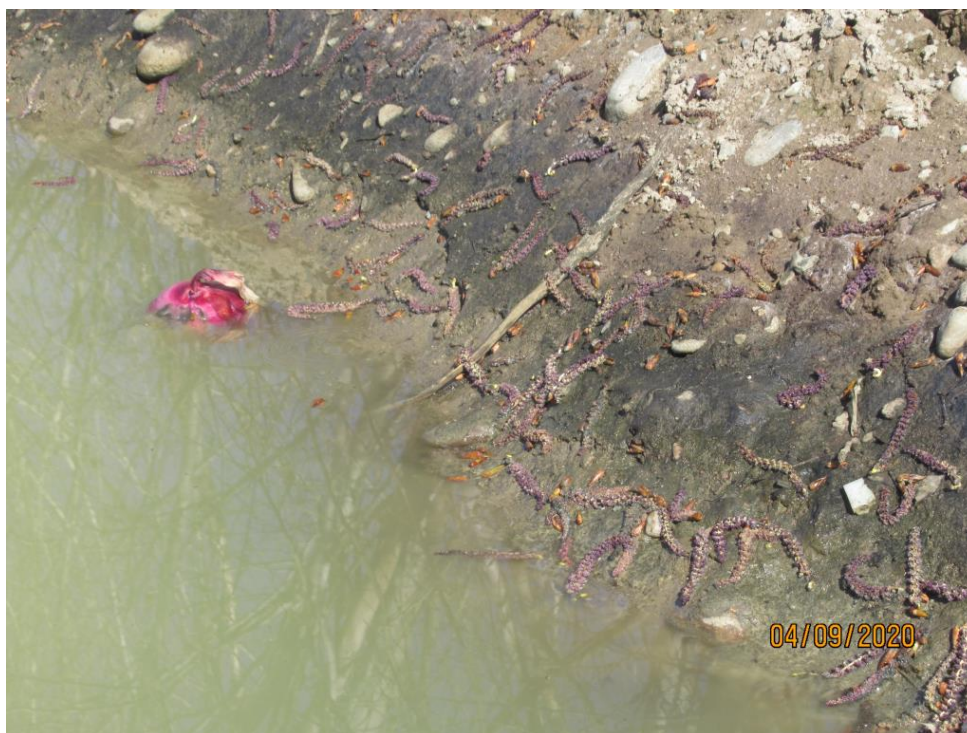
Photograph 44 :Close-up view of Swale #3, northeast end, note discoloration of soil, appears to be oil or petroleum based.

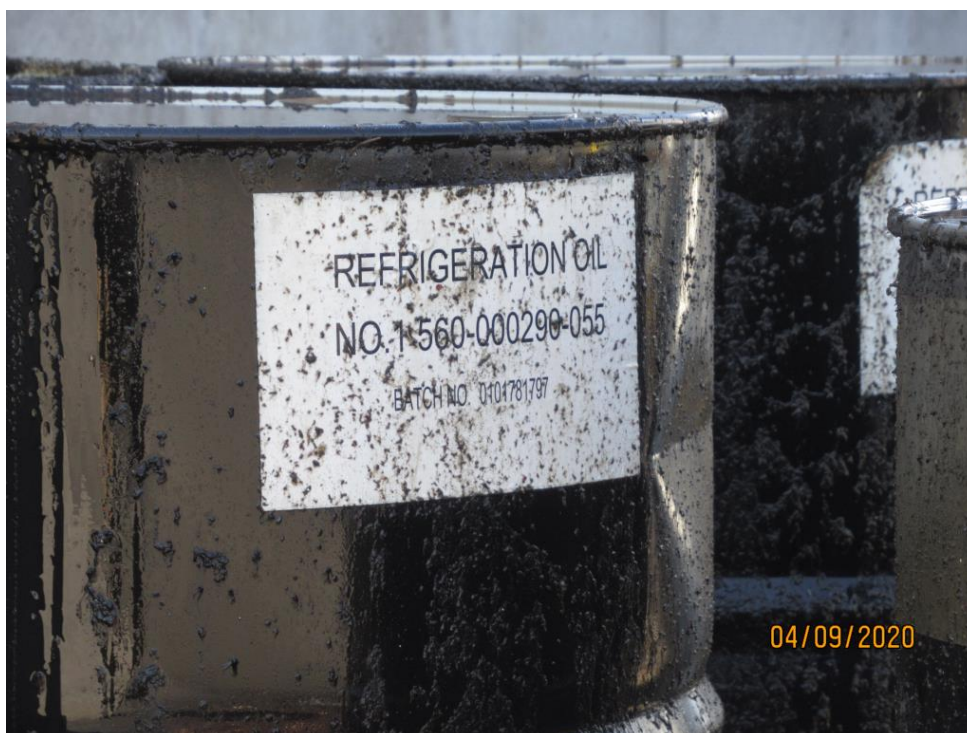
Photograph 46 :Label on one of the drums indicating refrigeration oil.

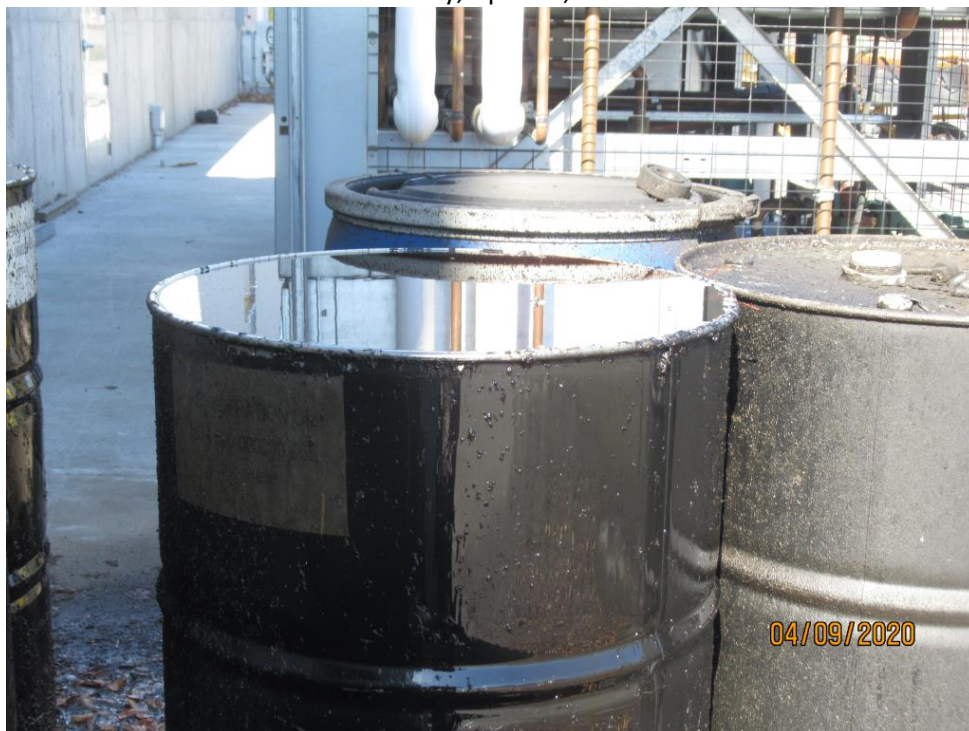
Photograph 47 :Refrigeration oil drums, note oil pooling on the top and leaking around the sides.

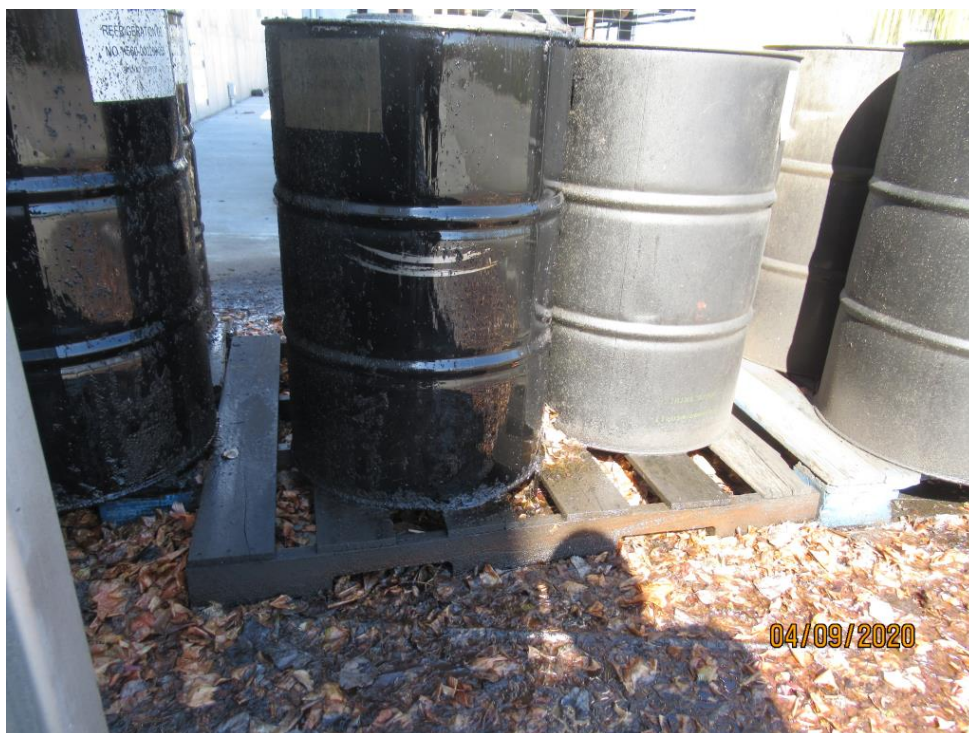
Photograph 48 :Storage pallets and refrigeration oil drums.

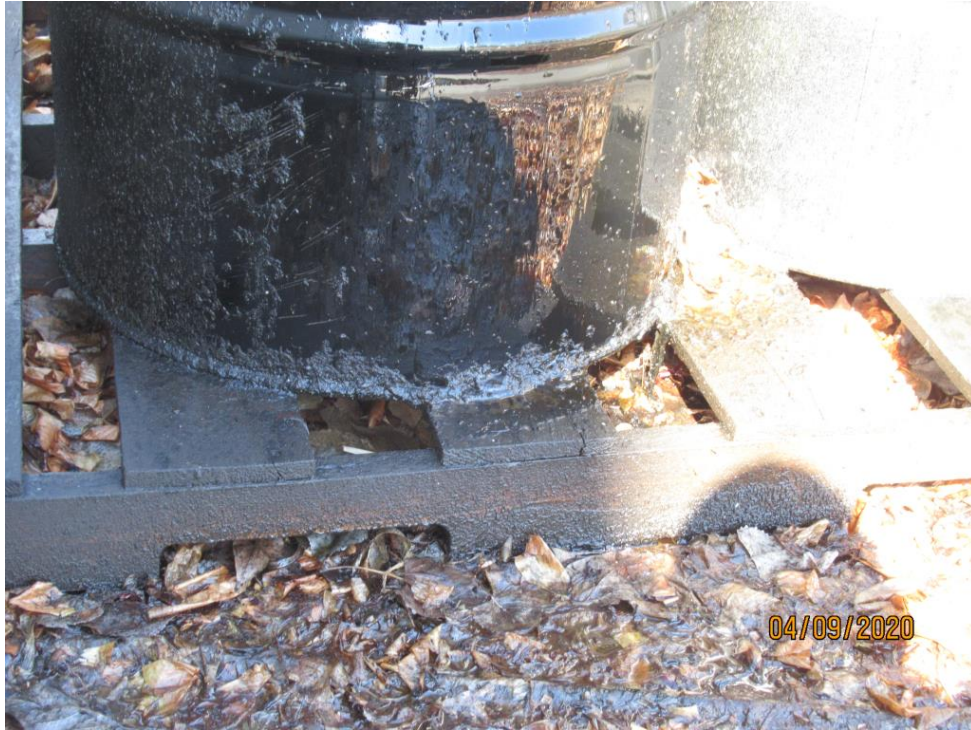
Photograph 49 :Leaking oil from refrigeration oil drums on to storage pallets.

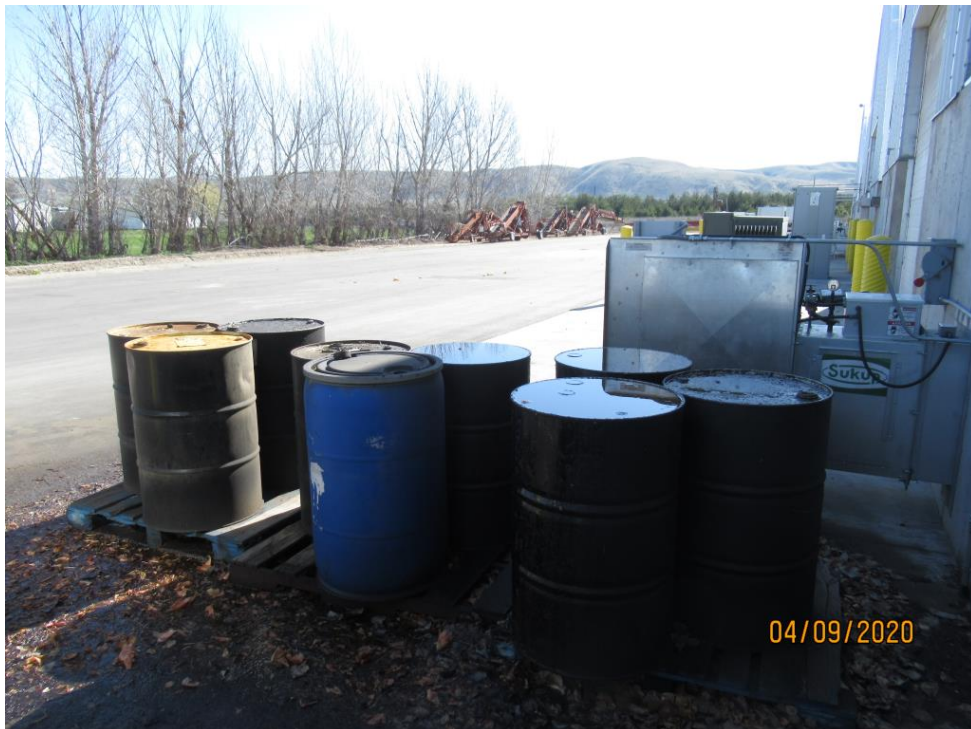
Photograph 50 :Refrigeration oil drums, stored near Swale #3, looking east.

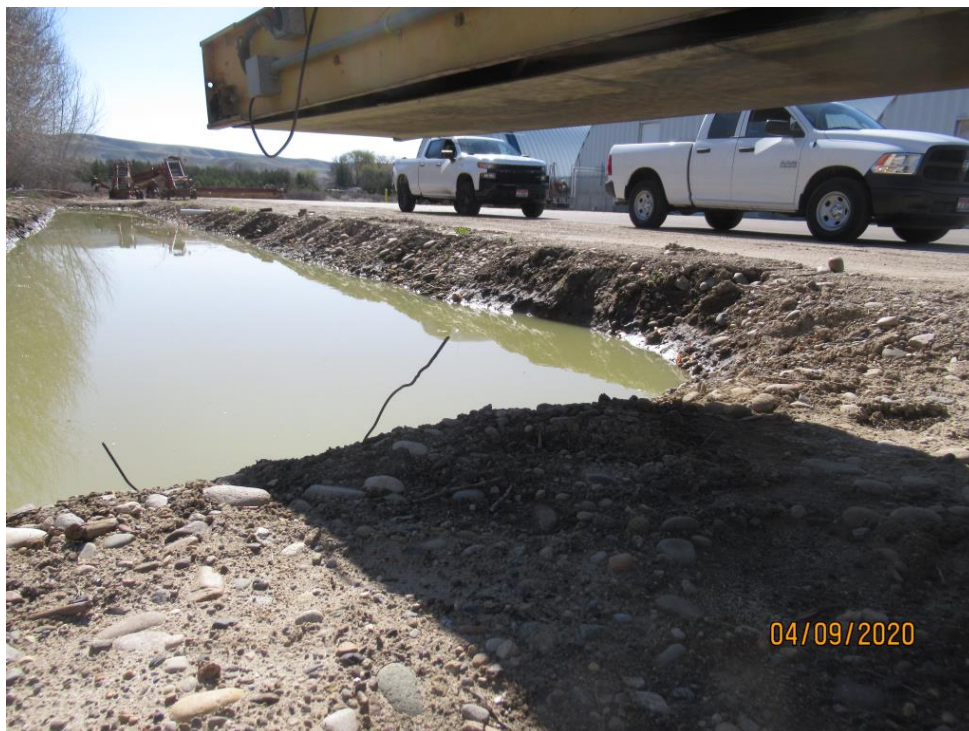
Photograph 52 :Swale #3, west end of the swale, looking east.

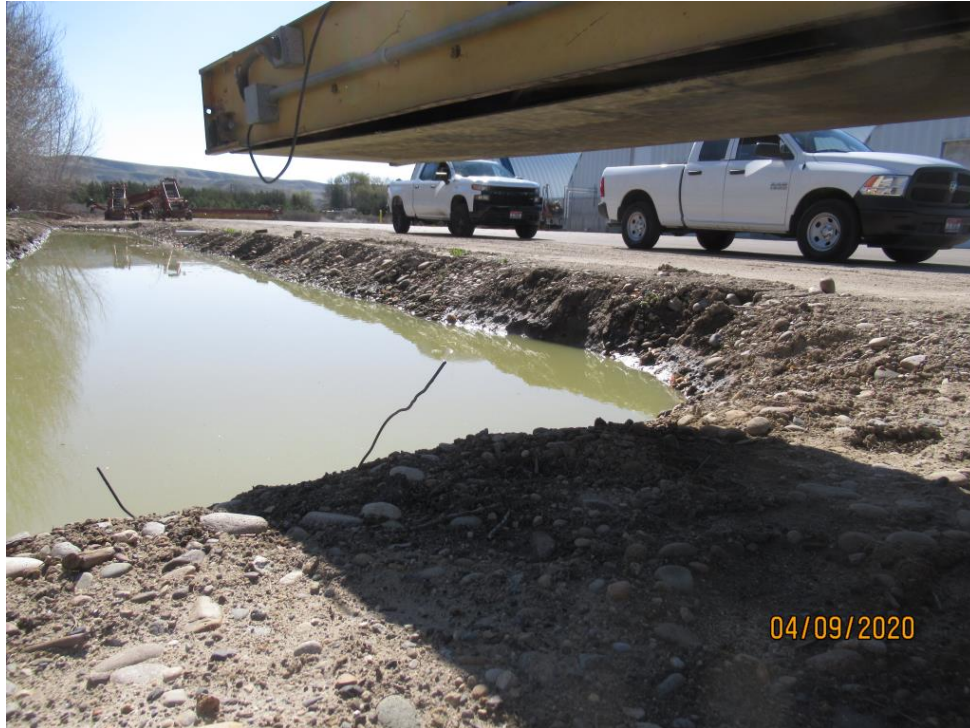
Photograph 53 :Swale #3, west end of the swale, looking east, second view.

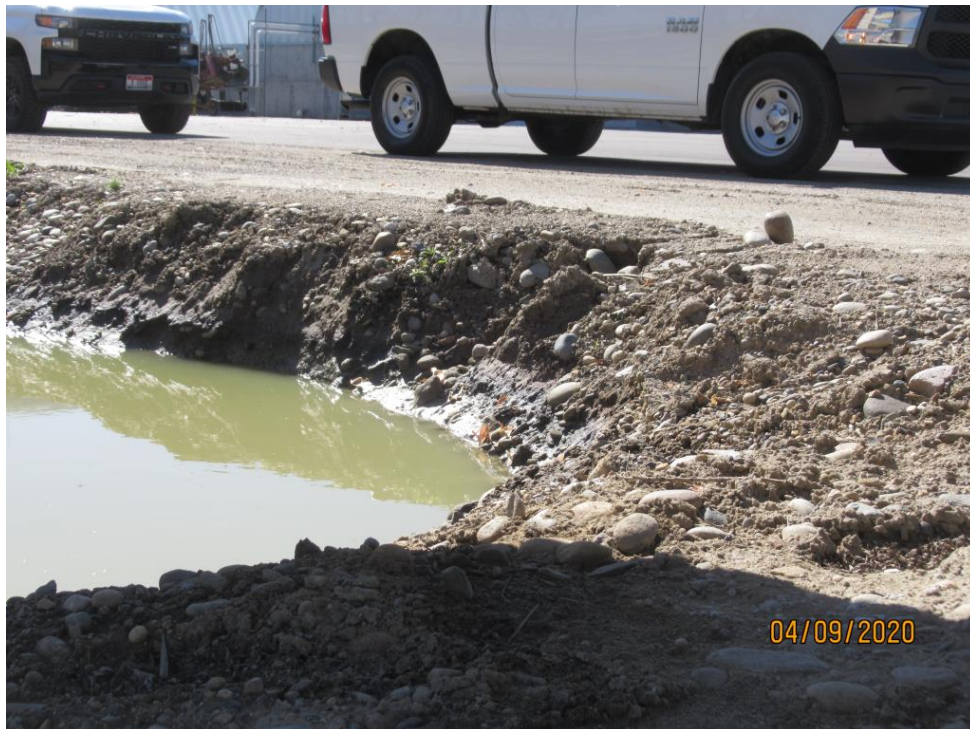
Photograph 54 :Rills on southwest bank of Swale #3.

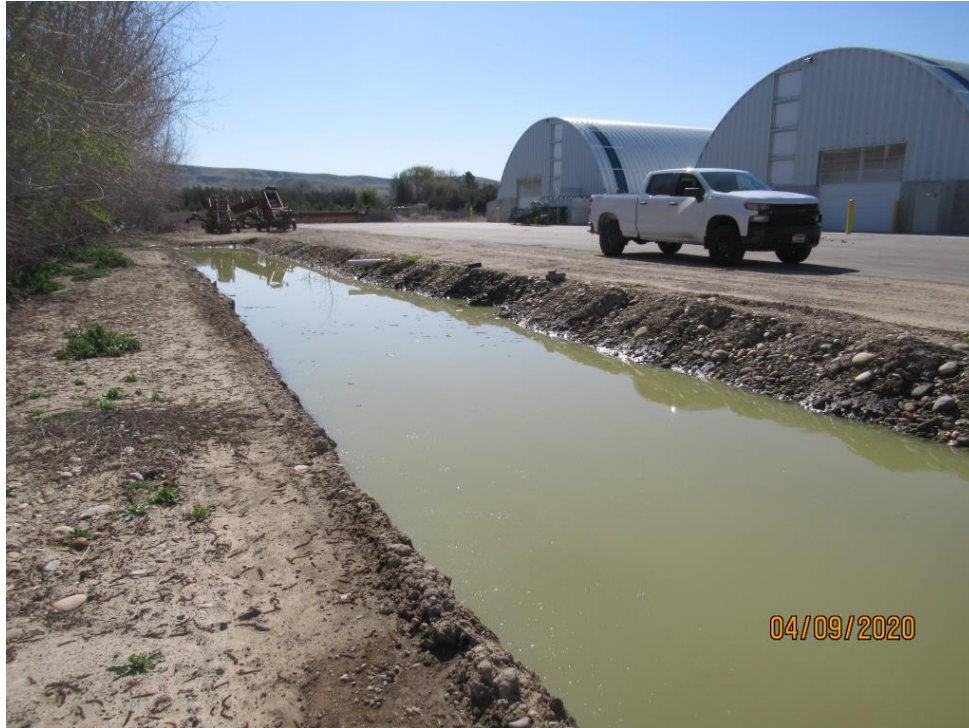
Photograph 55 :Swale #3, looking east.

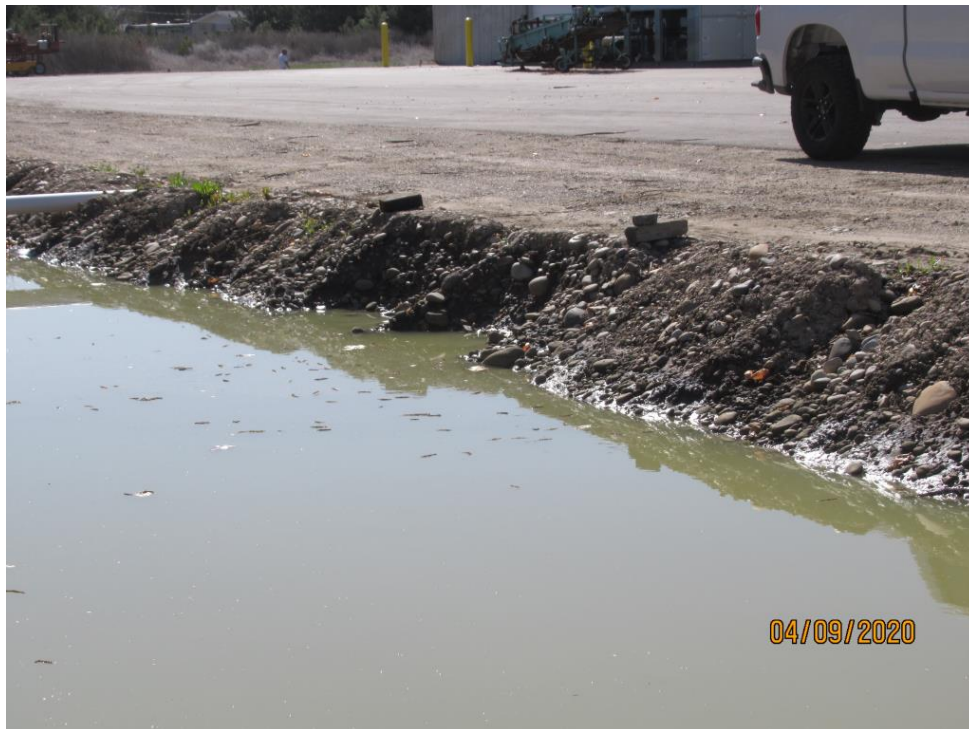
Photograph 56 :Rills on south bank of Swale #3.

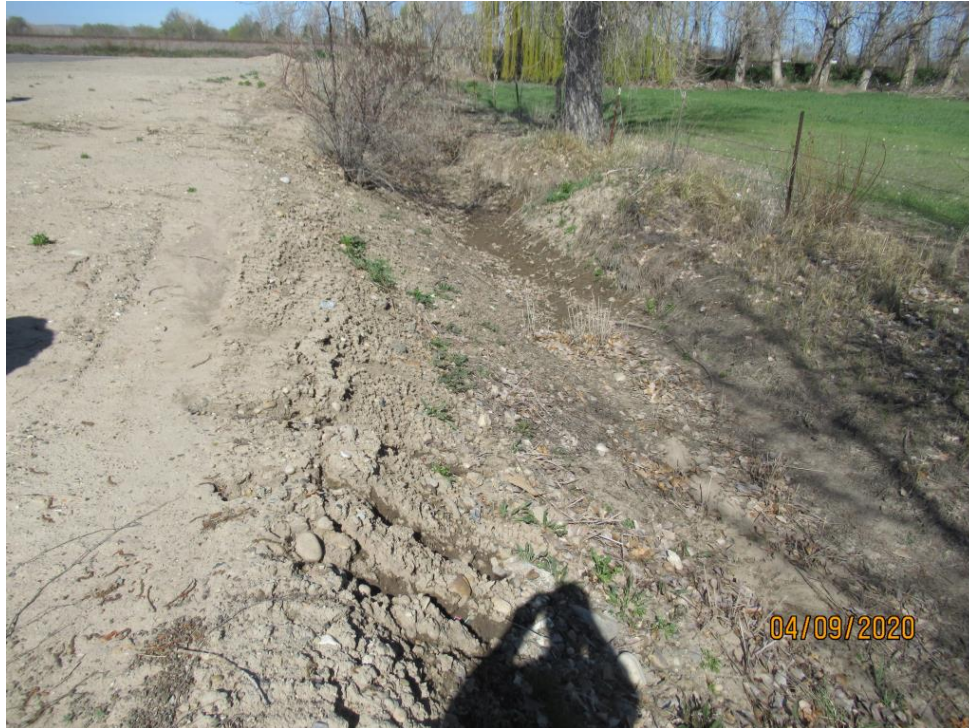
Photograph 57 :Irrigation ditch on north side of property looking west, note moist soil in ditch bottom does not extend to foreground.

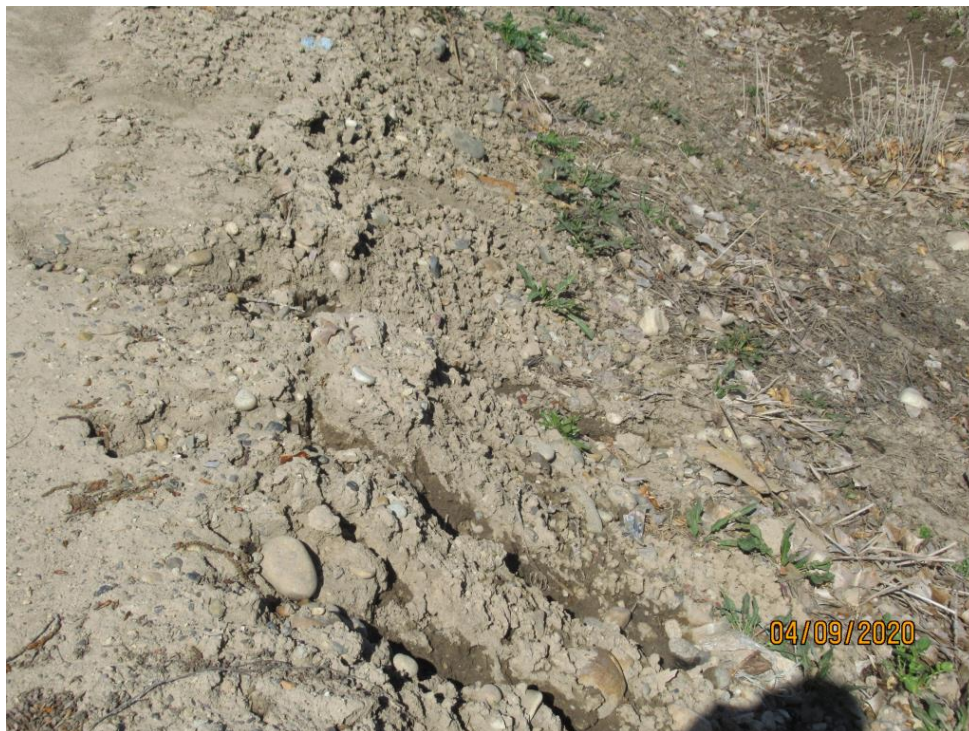
Photograph 58 :Rills on facility property into north side irrigation ditch.

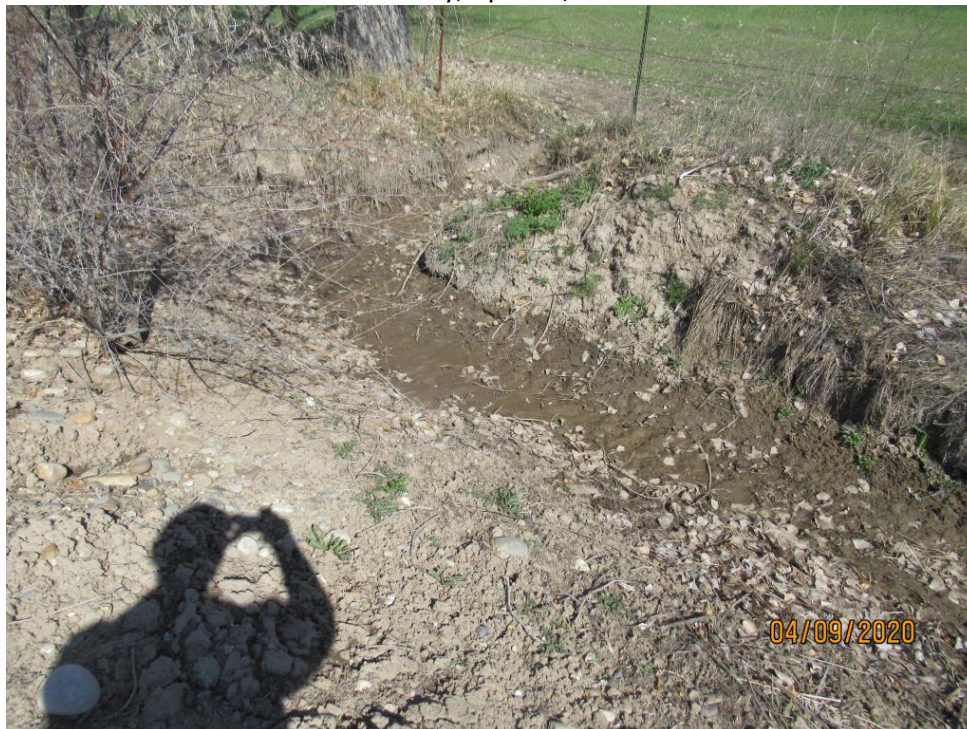
Photograph 59 :Irrigation ditch and moist soil on north side of property, looking north.

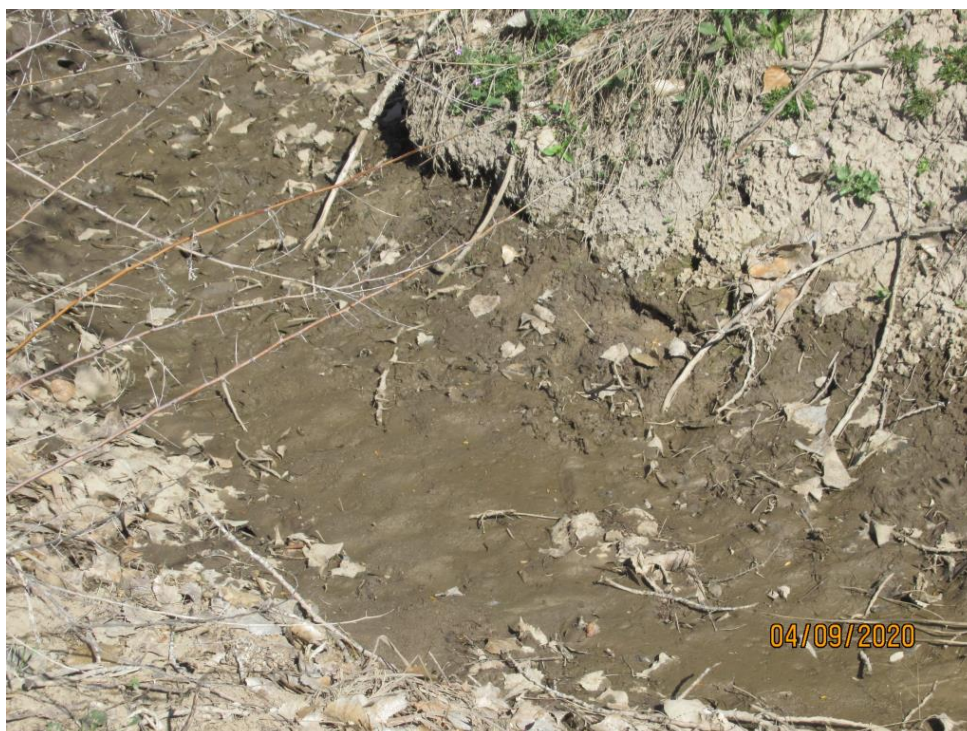
Photograph 60 :Close-up view of moist soil in irrigation ditch north side of property.

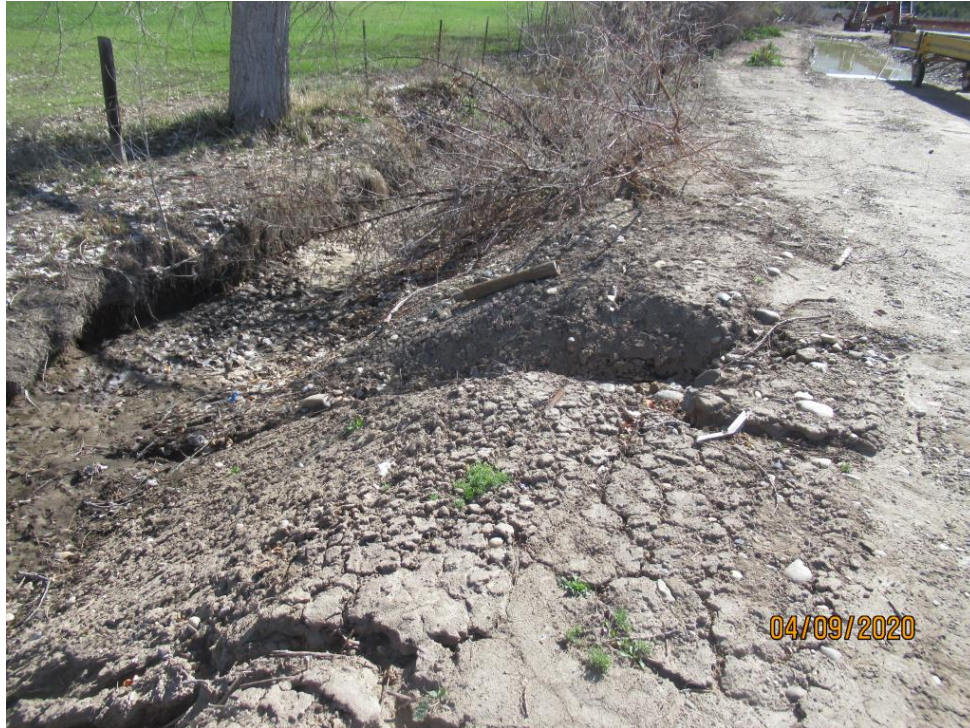
Photograph 61 :Large rill on facility property into north side irrigation ditch, looking east.

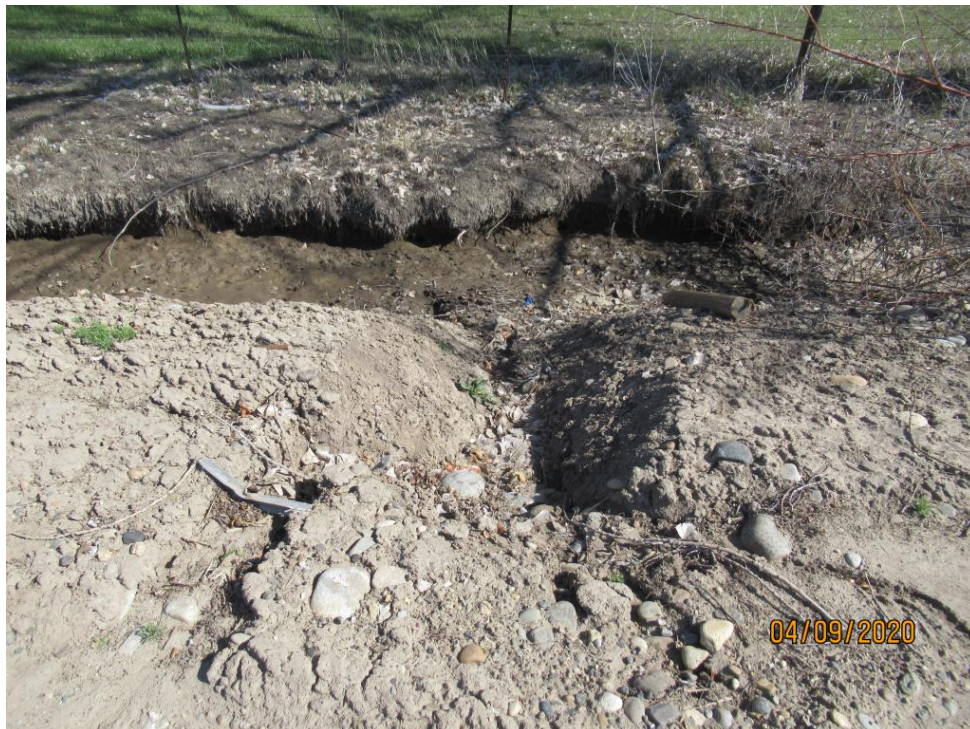
Photograph 62 :Large rill on facility property into north side irrigation ditch, looking north.

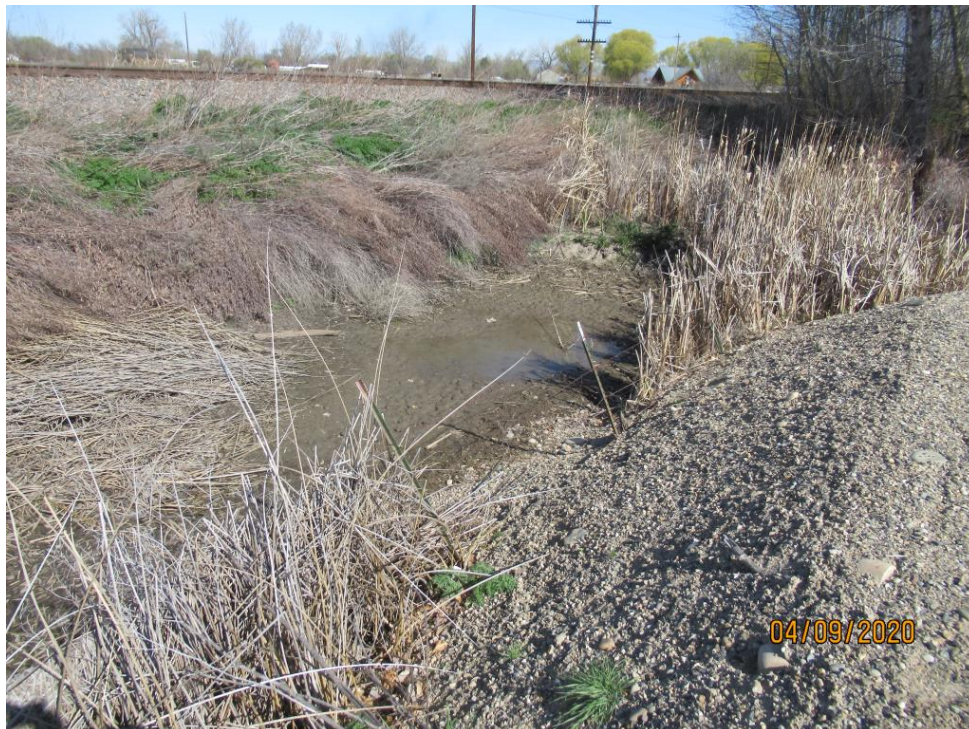
Photograph 64 :Pooling water in irrigation ditch, west side of the property, looking north.

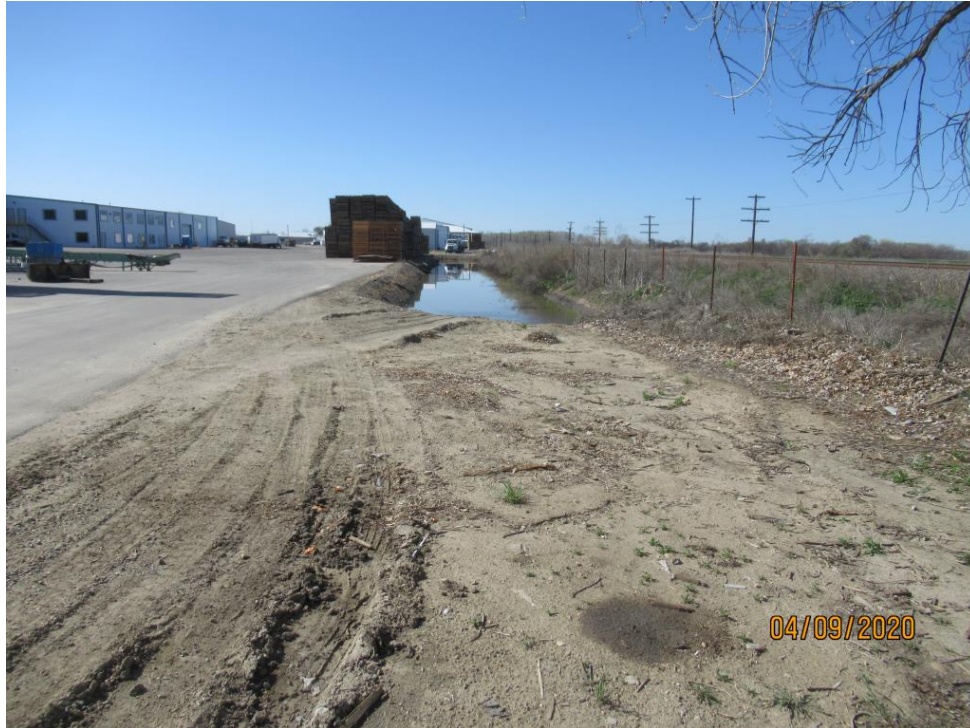
Photograph 65 :Stormwater swale, Swale #4, located on the west side of the property, looking southwest.

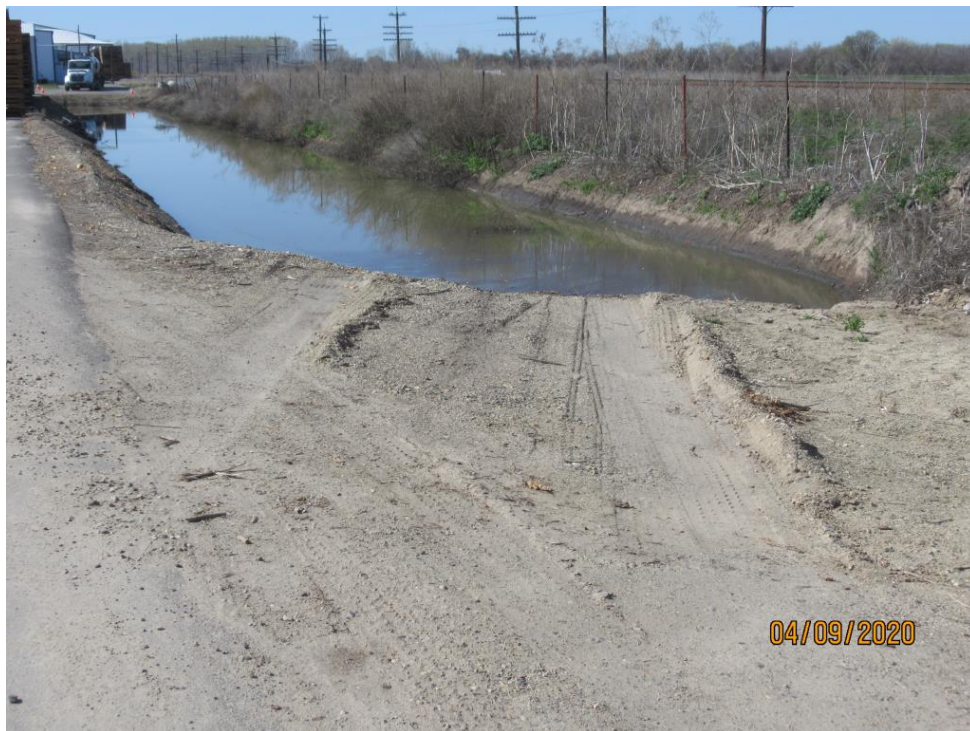
Photograph 66 :Swale #4, northeast end, looking southwest, note tire tracks to edge of swale.

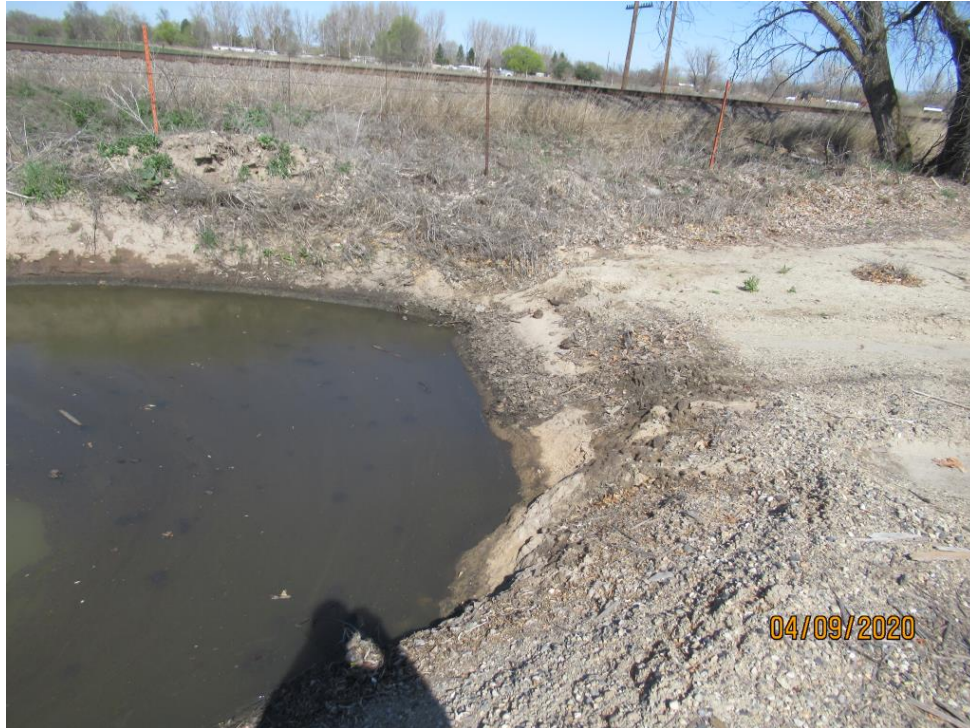
Photograph 67 :Swale #4, north end, looking northwest.
