## Photographic Documentation

**Name of Facility:** Partners Produce, Payette

**Inspection Date:** Thursday, April 09, 2020

**Purpose of Inspection:** Complaint investigation

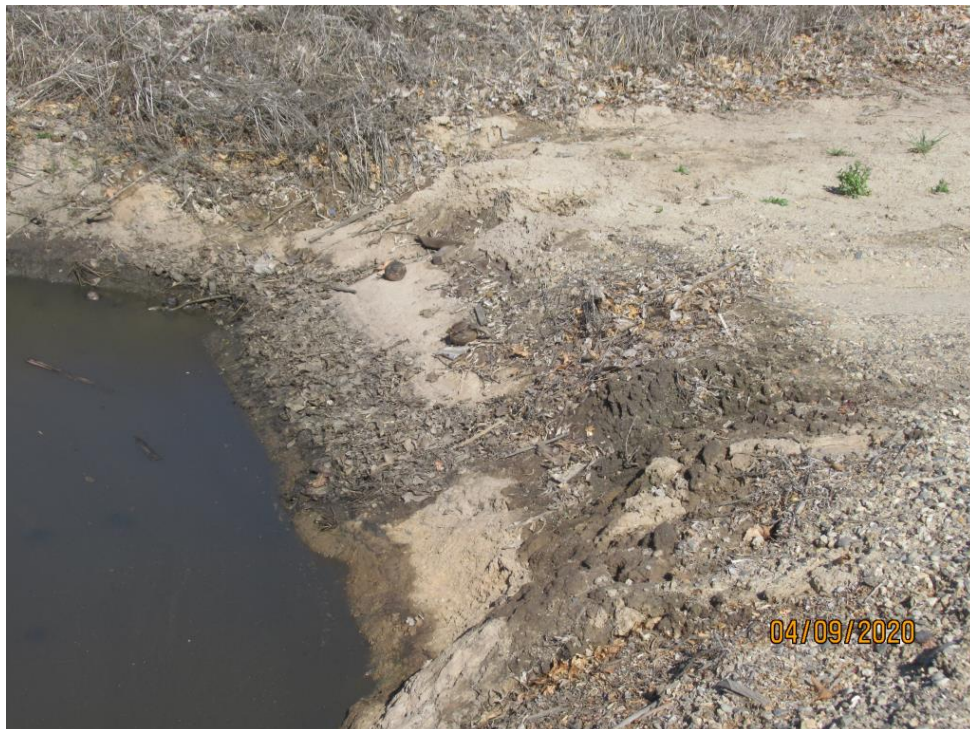
Photograph 68 :Close-up view of Swale #4 north end.

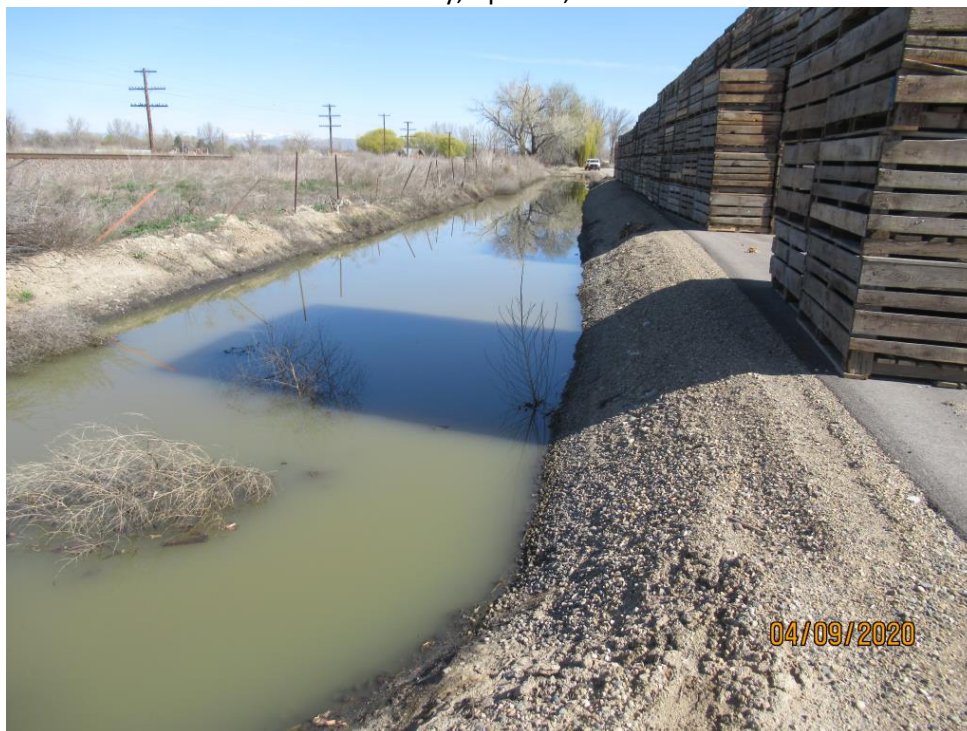
Photograph 69 :Swale #4, looking north from the south end.

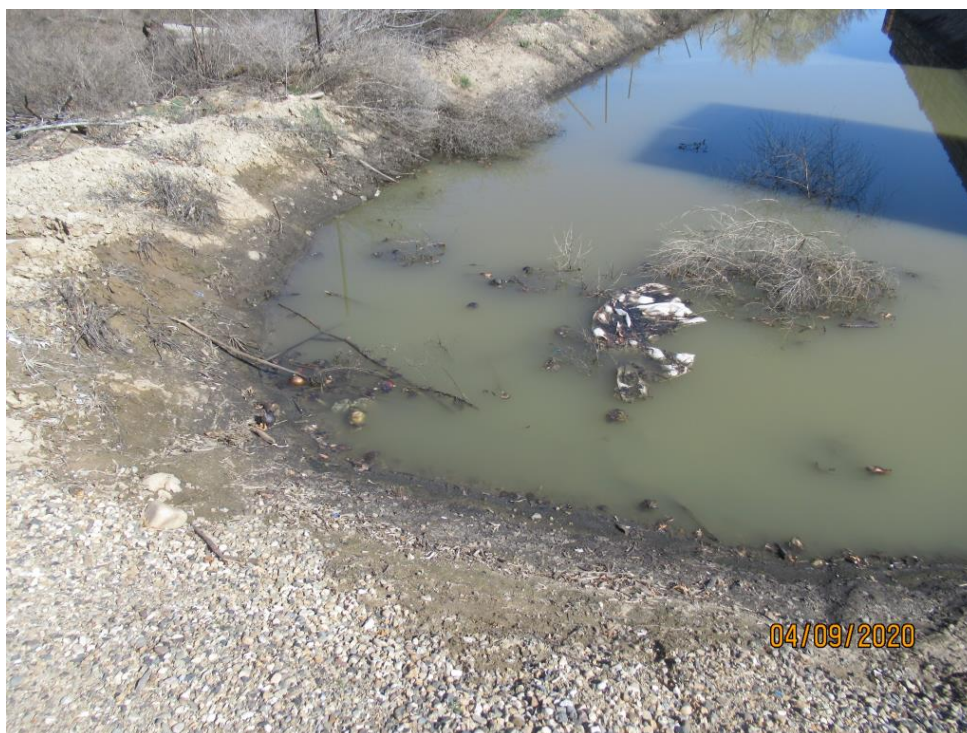
Photograph 70 :Close-up view of Swale #4, south end.

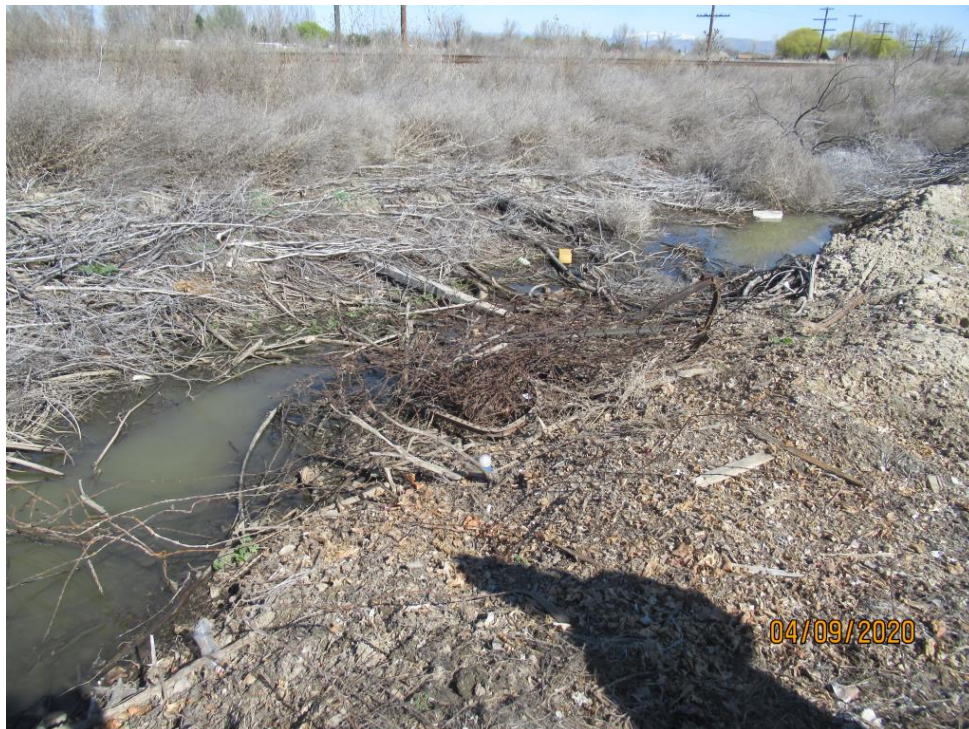
Photograph 72 :West side of property near waste water truck loading station, between station and Swale #4, looking northwest.

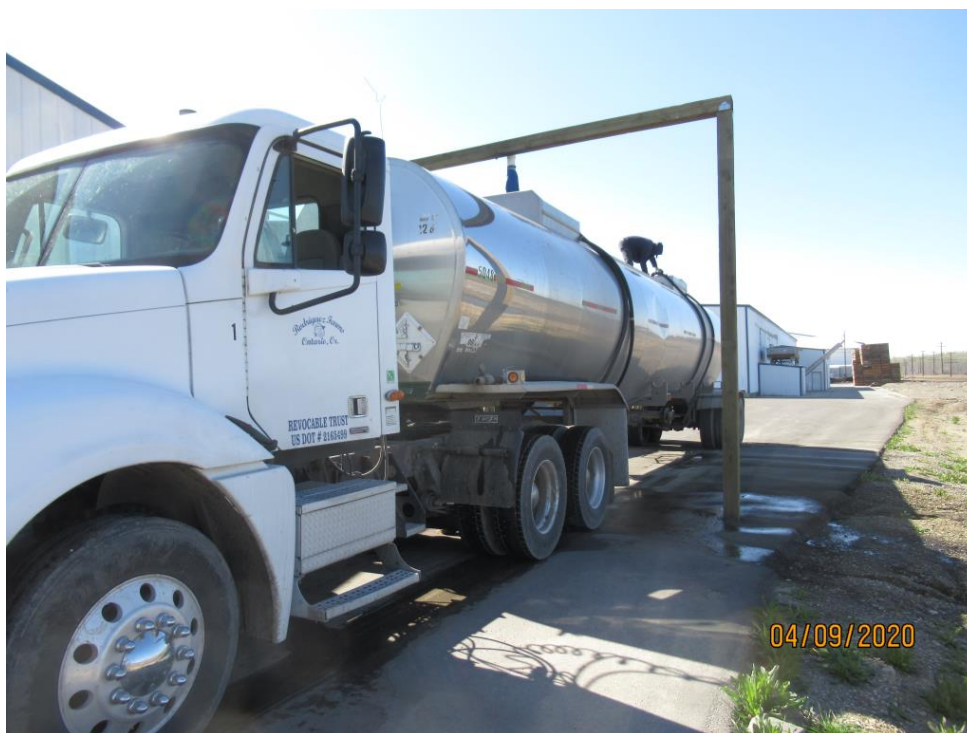
Photograph 74 :Waste water truck loading station located on the west side of the property.

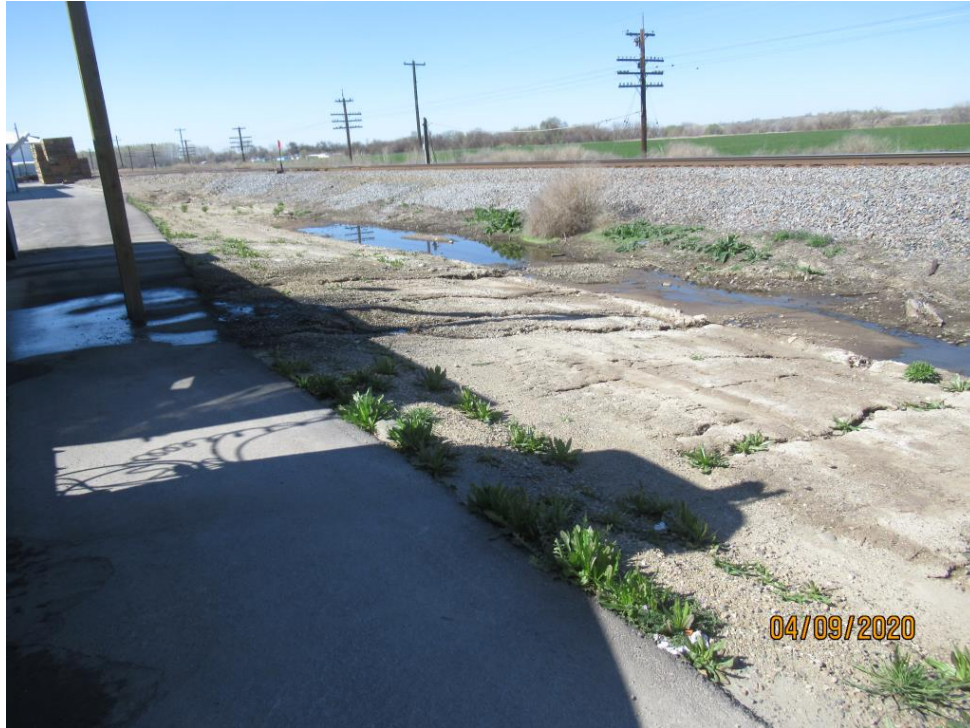
Photograph 75 :View from waste water truck loading station looking west southwest.

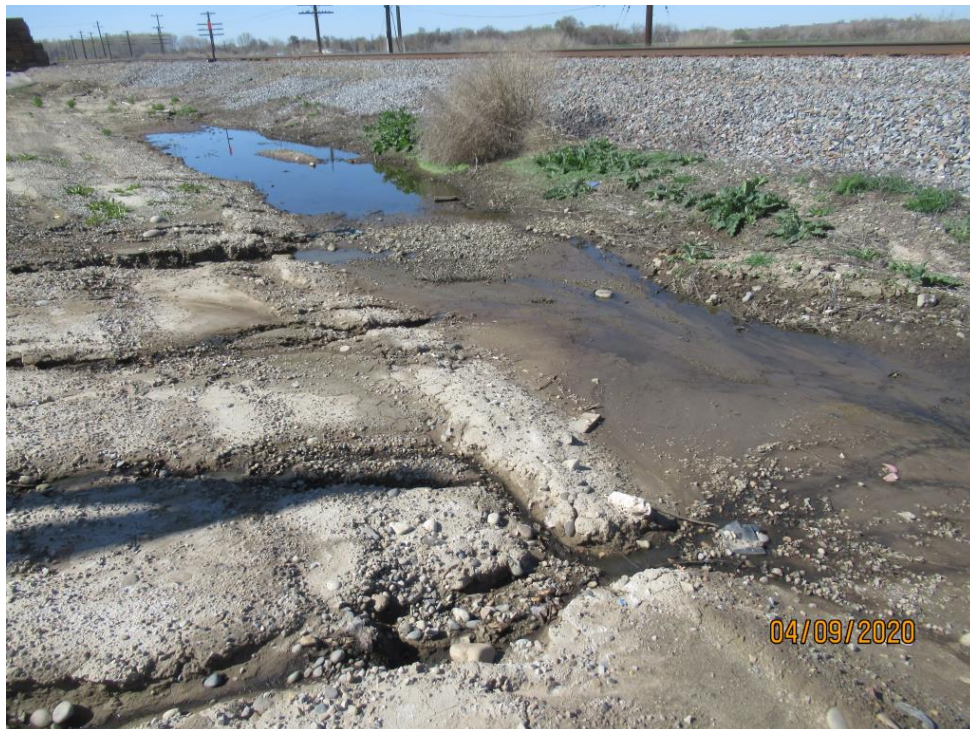
Photograph 76 :Rills and waste water from truck loading operations.
