### Outline of Inadequacies of Mr. Lee's Current Application

# MASTER MAP OUTLINING **CONCERNS** AND INADEQUACIES **OF MINING** APPLICATION

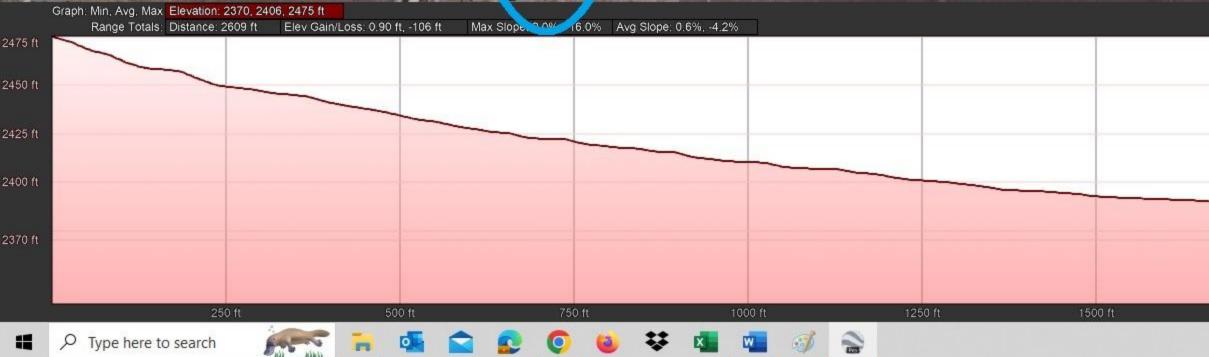
The property in question drops approximately 105 feet from the Western Side to the Eastern side. Ground Water drains from West To East DIRECTLY toward 5 different Homes, EACH with residential wells pulling from the same ground water aquafer. This slope equates to slightly over a 4% grade.

Grad Calculation: 2475-2370=105 feet 105/2609.03\*100=4.02%

Water percolating from the large canal and existing riparian areas will flow in this direction. Pollutants will come in contact with water and water will contaminate drinking wells.

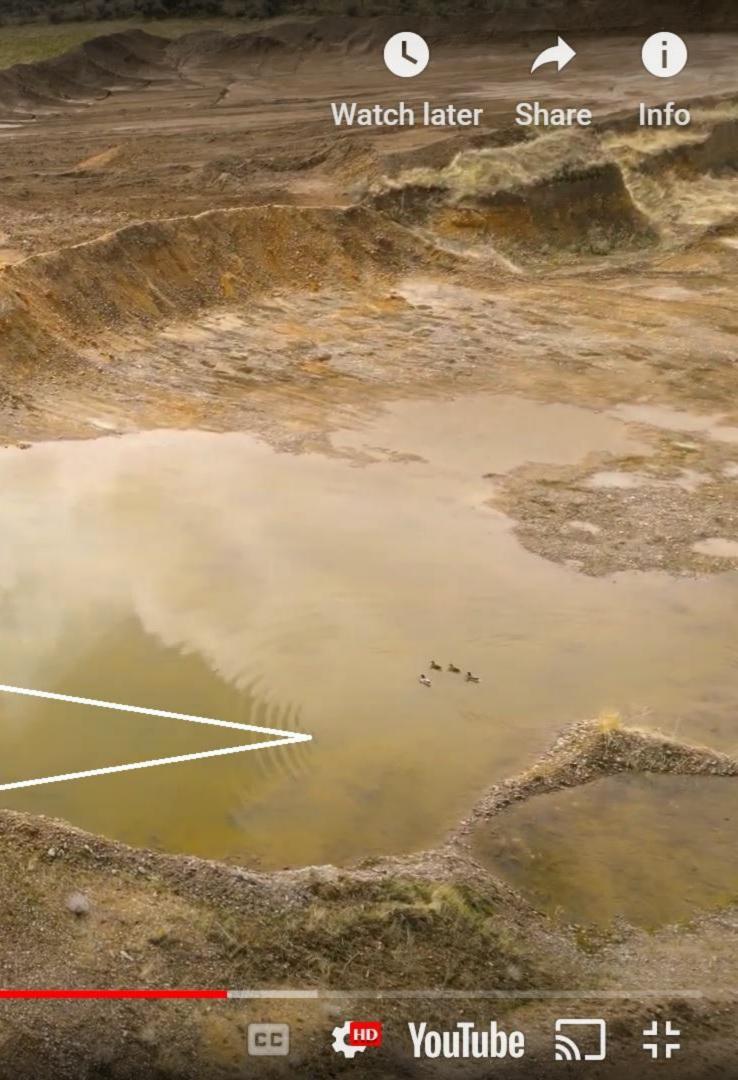
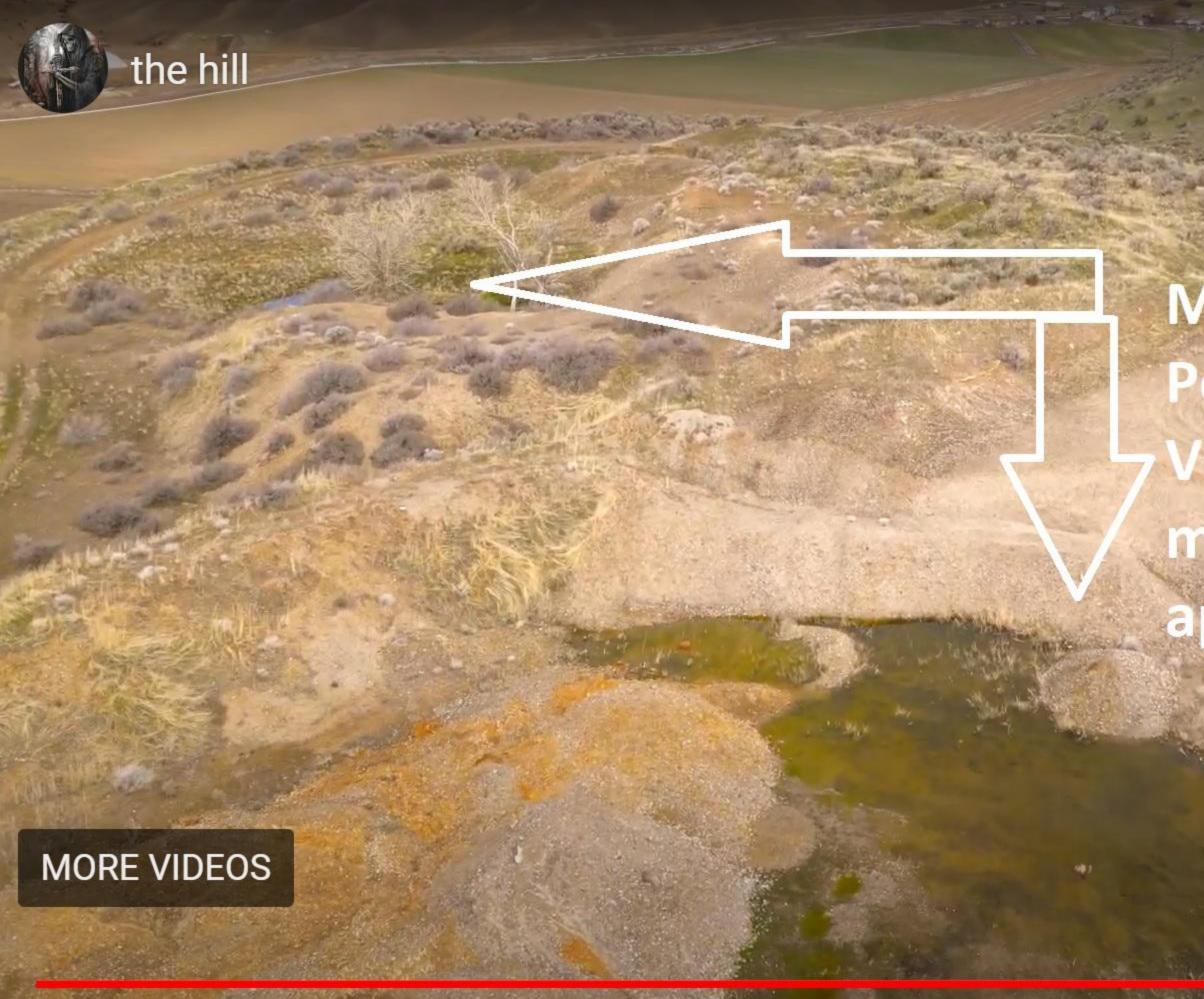
# Home with residential well in the direct drainage path of the perenial wetland

## Perenial Water with Ducks directly in the middle of "Location #3" in the application

**More Perenial Water and** Perenial Water dependant Vegitation directly in the middle of "Location #3" of application.
