## Photographic Documentation

**Name of Facility:** Partners Produce, Payette

**Inspection Date:** Thursday, April 09, 2020

**Purpose of Inspection:** Complaint investigation

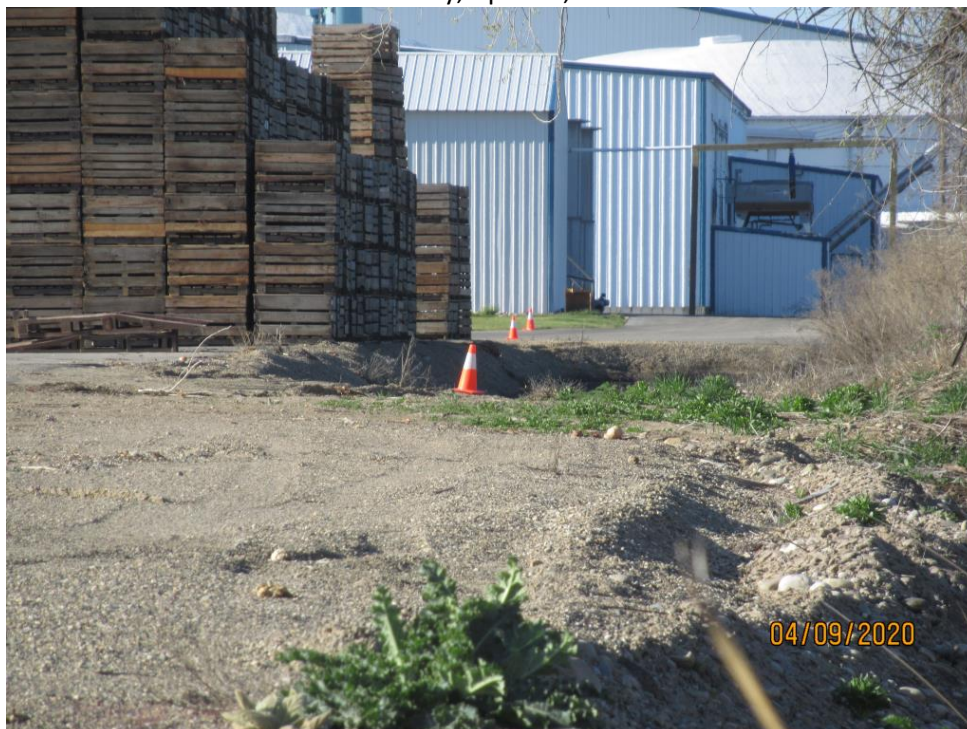
Photograph 21 :Close up view of stormwater swale located on the west side of the property, looking west.

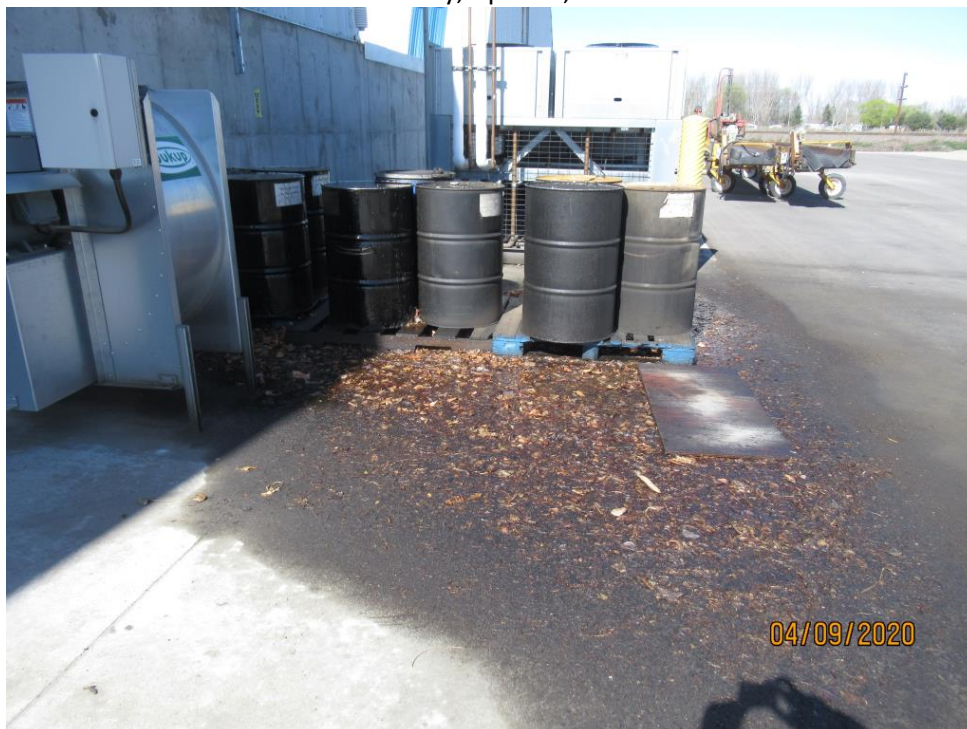
Photograph 45 :Refrigeration oil drums, stored on the north end of the property, near Swale #3. Facility representative indicated the drums contained used oil.

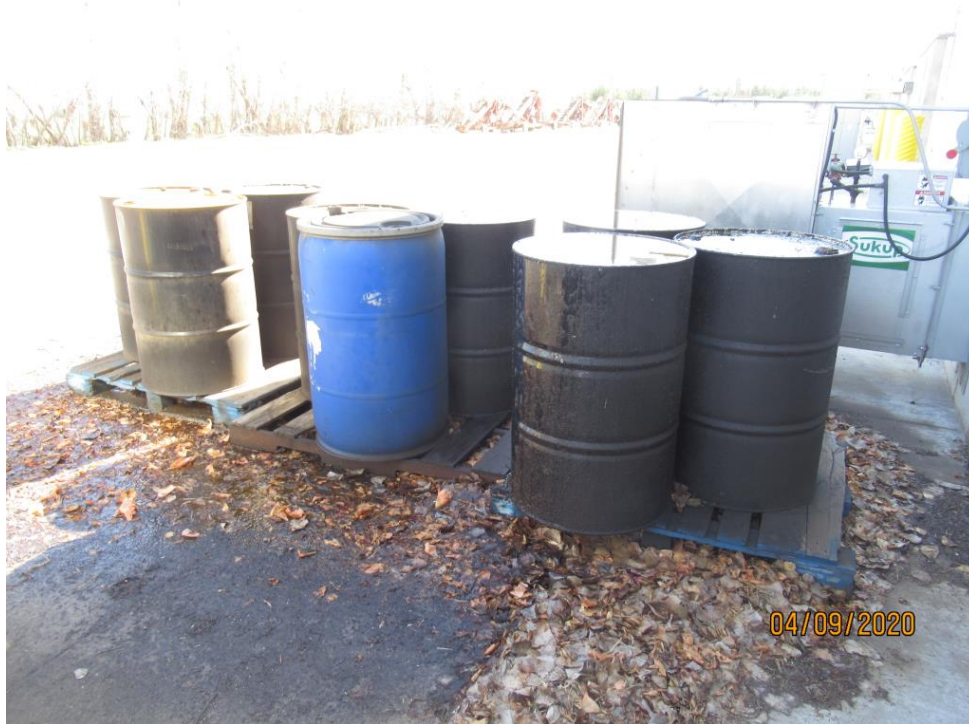
Photograph 51 :Refrigeration oil drums, stored near Swale #3, looking east, second view.

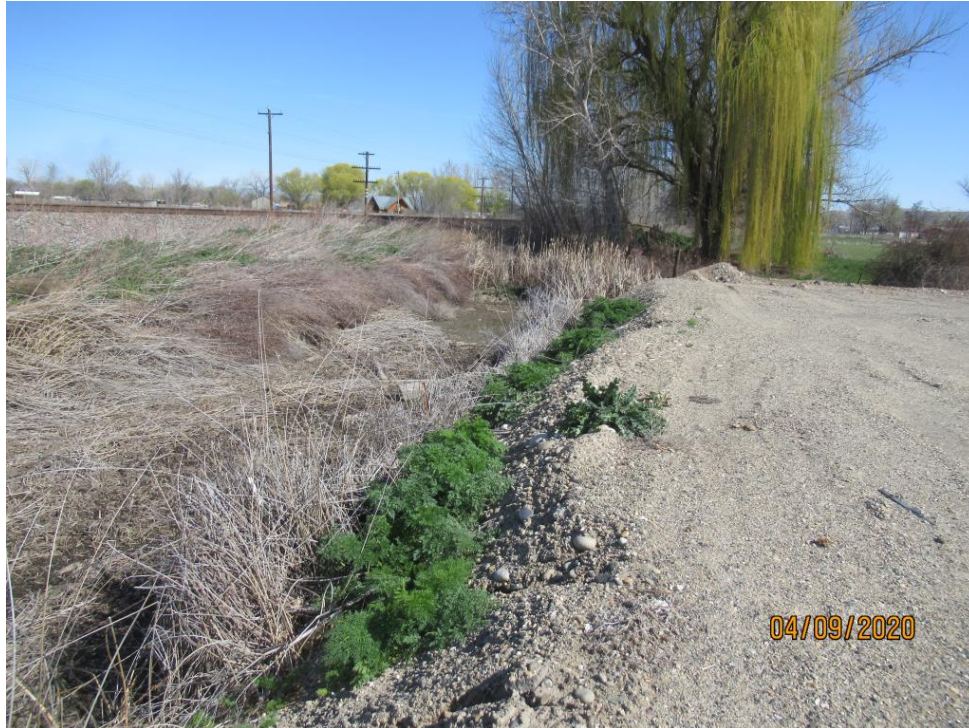
Photograph 63 :Irrigation ditch on west side of property looking north.

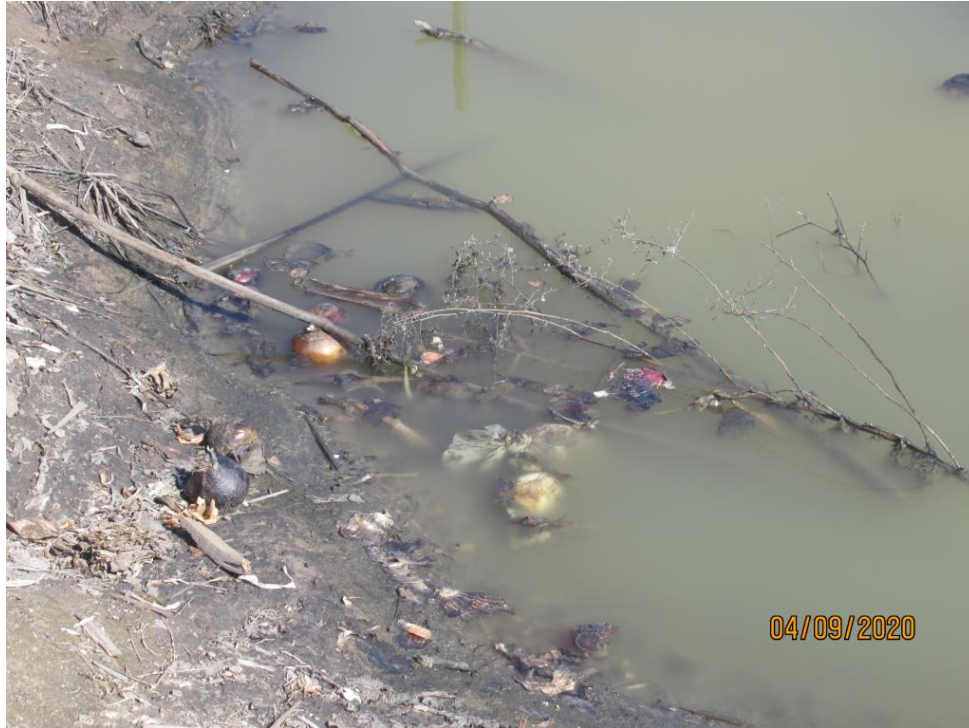
Photograph 71 :Close-up view of Swale #4, note onions and debris.

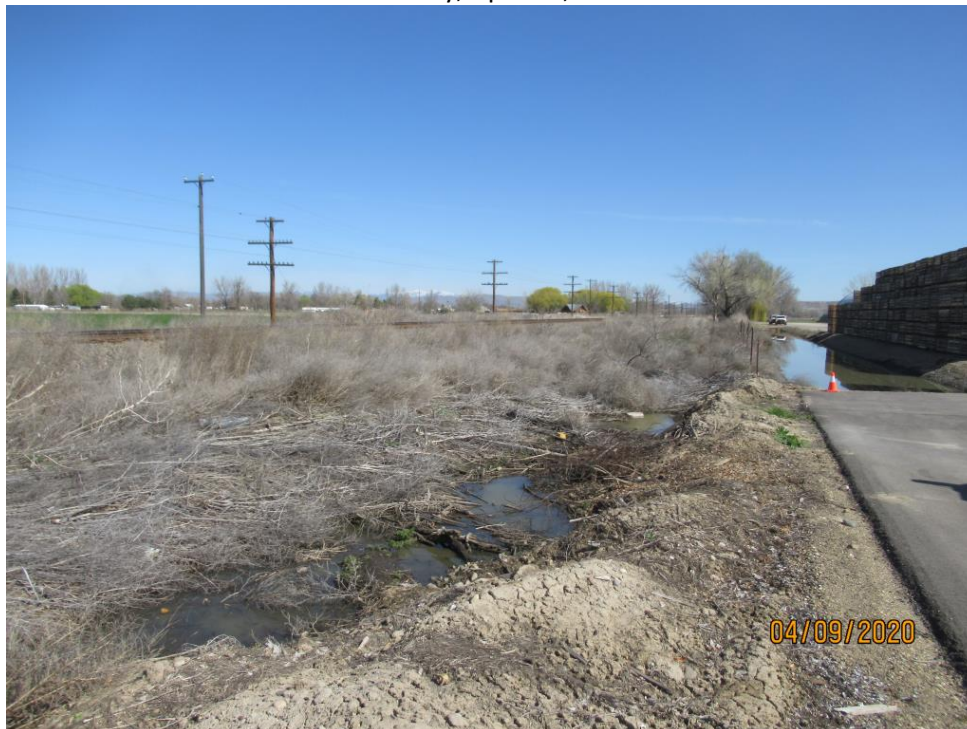
Photograph 73 :West side of property looking at pooling water and Swale #4, facing north.
